Access Compliance Report

Public Rights-of-Way

(Curb Ramps)

Intersection ID: 16506	Main Street: ELLINGTON_ST	Cross Street: N_WENDOVER_RD	Location: NE
ADA ID: 6136FECC5477	Ramp Type: Perp	Initial Pass/Fail: Pass	Overall Compliance: No
Severity Score: 5.25			
Codes/Mitigation Info/Possible Solution		Field Measurements/Component Compliance

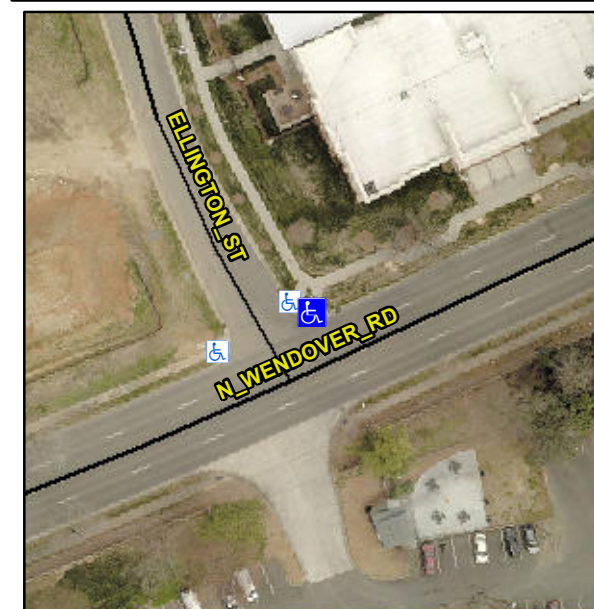
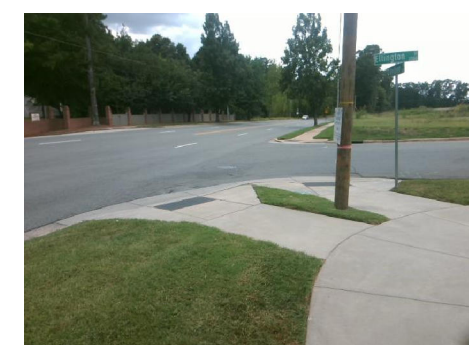
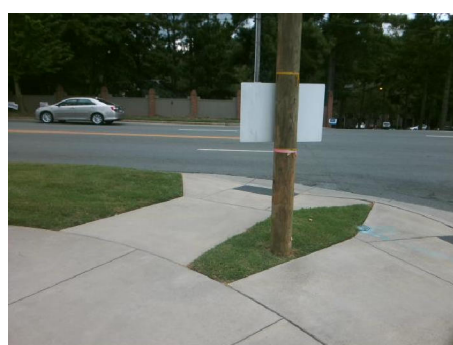
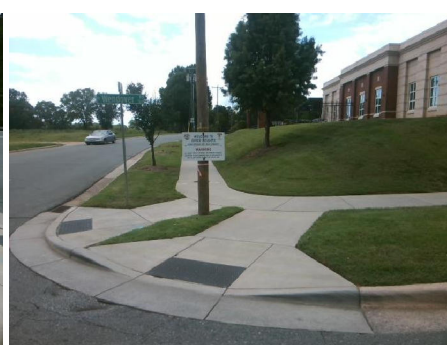
Compliance	Description	Data	Compliance	Description	Data
N/A	Ramp Length (in)	65.0	Yes	Ramp Slope (%)	7.2
Yes	Ramp Width (in)	48.0	No	Ramp XSlope (%)	3.3
N/A	Flare Type LT	Sloped	N/A	Flare Type RT	N/A
N/A	Flare Slope LT (%)	7.5	No	Flare Slope RT (%)	12.5
N/A	Flare Traversable LT?	Yes	N/A	Flare Traversable RT?	Yes
Yes	Landing Length (in)	88.5	Yes	DWS Provided?	Yes
Yes	Landing Width (in)	48.0	Yes	DWS Contrast?	Yes
No	Landing Slope (%)	4.8	Yes	DWS Length (in)	24.5
No	Landing X Slope (%)	3.6	Yes	DWS Full Width?	Yes
N/A	Landing Curb? (Y/N)	No	Yes	DWS Offset (in)	1.5
N/A	Shared Landing?	No			
Yes	Gutter Ponding?	No	Yes	Gutter Slope (%)	0.6
Yes	Gutter Lip Ht (in)	0.0	Yes	Gutter X Slope (%)	2.1
N/A	Painted X Walk1?	No	N/A	Painted X Walk2?	N/A
	X Walk 1 Direction	To S		X Walk 2 Direction	N/A
N/A	X Walk 1 Width (in)	N/A	N/A	X Walk 2 Width (in)	N/A
	X Walk 1 Slope (%)	1.4		X Walk 2 Slope (%)	N/A
	X Walk 1 X Slope (%)	2.7		X Walk 2 X Slope (%)	N/A

N/A	Ramp inside XWalk1?	N/A	N/A	Ramp inside XWalk2?	N/A
	Road Slope (%)	N/A	N/A	Clear Space?	Yes
	Road X Slope (%)	N/A	N/A	Clear Space to XWalk (in)	N/A
Yes	Any Obstructions?	No	Yes	Storm Grate/Utility Hazard?	No
	Obstruction Type			Storm Grate/Utility Type	
			N/A		N/A
			Yes	Surface Condition? (G/P)	Good

Possible Solutions:

Remove & Replace Entire Ramp.
