# Access Compliance Report

## Public Rights-of-Way

### (Curb Ramps)

Intersection ID: 14692	Main Street: BAXTER_ST	Cross Street: QUEENS_RD	Location: W
ADA ID: 613C18AC8EE2	Ramp Type: PerpDiag	Initial Pass/Fail: Fail	Overall Compliance: No
Severity Score: 25			
Codes/Mitigation Info/Possible Solution		Field Measurements/Component Compliance

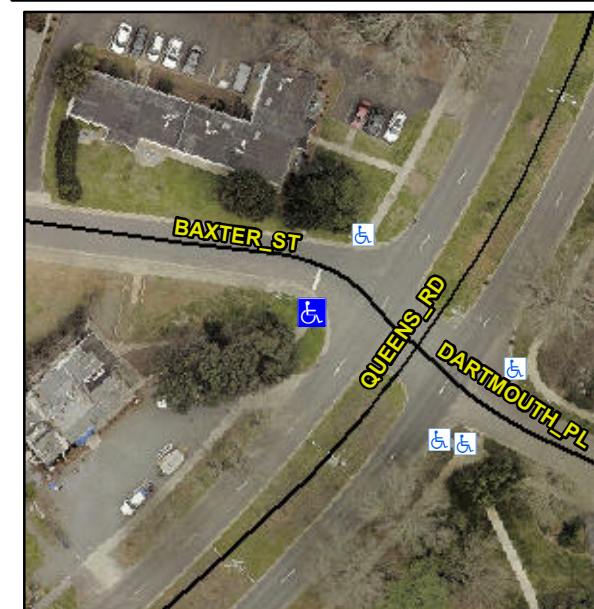
**Not Found, R304.2.2, R304.5.3**

Compliance	Description	Data	Compliance	Description	Data
N/A	Ramp Length (in)	144.0	No	Ramp Slope (%)	11.8
Yes	Ramp Width (in)	48.0	No	Ramp XSlope (%)	6.2
N/A	Flare Type LT	N/A	N/A	Flare Type RT	N/A
N/A	Flare Slope LT (%)	N/A	N/A	Flare Slope RT (%)	N/A
N/A	Flare Traversable LT?	N/A	N/A	Flare Traversable RT?	N/A
N/A	Landing Length (in)	N/A	N/A	DWS Provided?	N/A
N/A	Landing Width (in)	N/A	N/A	DWS Contrast?	N/A
N/A	Landing Slope (%)	N/A	N/A	DWS Length (in)	N/A
N/A	Landing X Slope (%)	N/A	N/A	DWS Full Width?	N/A
N/A	Landing Curb? (Y/N)	N/A	N/A	DWS Offset (in)	N/A
N/A	Shared Landing?	N/A			
N/A	Gutter Ponding?	N/A	N/A	Gutter Slope (%)	N/A
N/A	Gutter Lip Ht (in)	N/A	N/A	Gutter X Slope (%)	N/A
N/A	Painted X Walk1?	No	N/A	Painted X Walk2?	No
	X Walk 1 Direction	To SE		X Walk 2 Direction	To NE
N/A	X Walk 1 Width (in)	N/A	N/A	X Walk 2 Width (in)	N/A
	X Walk 1 Slope (%)	5.9		X Walk 2 Slope (%)	0.2
	X Walk 1 X Slope (%)	0.1		X Walk 2 X Slope (%)	5.2

N/A	Ramp inside XWalk1?	N/A	N/A	Ramp inside XWalk2?	N/A
	Road Slope (%)	4.6	N/A	Clear Space?	N/A
	Road X Slope (%)	3.9	N/A	Clear Space to XWalk (in)	N/A
N/A	Any Obstructions?	N/A	N/A	Storm Grate/Utility Hazard?	N/A
	Obstruction Type			Storm Grate/Utility Type	
		N/A			N/A
		Yes		Surface Condition? (G/P)	Good

**Remove & Replace Curb Ramp With Two New Directional Ramps or Equivalent.**

Total Cost: \$ 3200.00
