## **Access Compliance Report Public Rights-of-Way** (Curb Ramps)

Intersection ID: 10241 Main Street: ROZZELLES FERRY RD Cross Street: S TURNER AV Location: Ν **ADA ID: 6142A909BDFB Overall Compliance: No Severity Score:** 0 Ramp Type: Combination1Diag Initial Pass/Fail: Fail

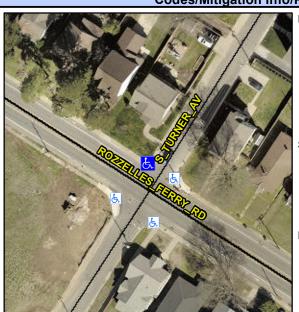
Not Found, R304.5.1, R304.2.2, R304.5.3, R304.3.2

None ROZZELLES FERRY RD StopSign S TURNER AV Possible Solutions: Remove & Replace Curb Ramp With Two New Directional Ramps or Equivalent.
