Access Compliance Report Public Rights-of-Way (Curb Ramps)

Intersection ID: 23353 Main Street: KNIGHTSWOOD DR **Cross Street: LANCER DR** Location: ADA ID: 614F79BDB594

Ramp Type: PerpDiag Initial Pass/Fail: Fail **Overall Compliance: No** Severity Score: 21.25

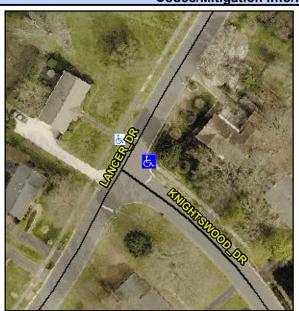
Field Measurements/Component Compliance						
Compliance Description			Data	Comp	liance Description	Data
	N/A	Ramp Length (in)	66.0	Yes	Ramp Slope (%)	7.3
	No	Ramp Width (in)	46.5	No	Ramp XSlope (%)	6.3
	N/A	Flare Type LT	N/A	N/A	Flare Type RT	N/A
	N/A	Flare Slope LT (%)	N/A	N/A	Flare Slope RT (%)	N/A
	N/A	Flare Traversable LT?	N/A	N/A	Flare Traversable RT?	N/A
	N/A	Landing Length (in)	N/A	N/A	DWS Provided?	N/A
	N/A	Landing Width (in)	N/A	N/A	DWS Contrast?	N/A
	N/A	Landing Slope (%)	N/A	N/A	DWS Length (in)	N/A
	N/A	Landing X Slope (%)	N/A	N/A	DWS Full Width?	N/A
	N/A	Landing Curb? (Y/N)	N/A	N/A	DWS Offset (in)	N/A
	N/A	Shared Landing?	N/A			
	N/A	Gutter Ponding?	N/A	N/A	Gutter Slope (%)	N/A
	N/A	Gutter Lip Ht (in)	N/A	N/A	Gutter X Slope (%)	N/A
	N/A	Painted X Walk1?	No	N/A	Painted X Walk2?	No
		X Walk 1 Direction	To NW		X Walk 2 Direction	To SW
	N/A	X Walk 1 Width (in)	N/A	N/A	X Walk 2 Width (in)	N/A
		X Walk 1 Slope (%)	0.4		X Walk 2 Slope (%)	7.2

X Walk 1 X Slope (%)	9.5		X Walk 2 X Slope (%)	0.1
	N/A	Ramp inside XWalk1?	N/A	N/A	Ramp inside XWalk2?	N/A
		Road Slope (%)	6.9	N/A	Clear Space?	N/A
		Road X Slope (%)	10.8	N/A	Clear Space to XWalk (in)	N/A
	N/A	Any Obstructions?	N/A	N/A	Storm Grate/Utility Hazard?	N/A

Possible Solutions: **Remove & Replace Curb Ramp With** Two New Directional Ramps or Equivalent. Surveyor Notes: N/A PROW/ADA: Not Found, R304.5.1, R304.5.3
