# Access Compliance Report

## Public Rights-of-Way

### (Curb Ramps)

Intersection ID: 12305	Main Street: E_5TH_ST	Cross Street: N_COLLEGE_ST	Location: N
ADA ID: 615F90202753	Ramp Type: PerpDiag	Initial Pass/Fail: Fail	Overall Compliance: No
			Severity Score: 33.75

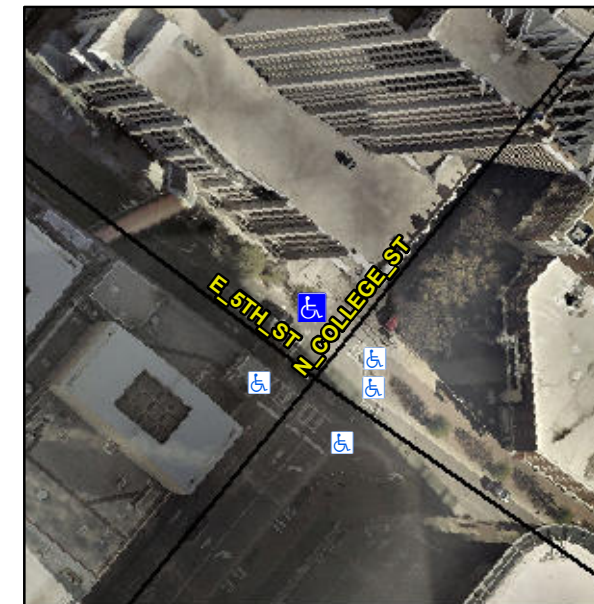
Compliance	Description	Data	Compliance	Description	Data
N/A	Ramp Length (in)	51.0	No	Ramp Slope (%)	10.0
No	Ramp Width (in)	36.0	No	Ramp XSlope (%)	6.2
N/A	Flare Type LT	N/A	N/A	Flare Type RT	N/A
N/A	Flare Slope LT (%)	N/A	N/A	Flare Slope RT (%)	N/A
N/A	Flare Traversable LT?	N/A	N/A	Flare Traversable RT?	N/A
N/A	Landing Length (in)	N/A	N/A	DWS Provided?	N/A
N/A	Landing Width (in)	N/A	N/A	DWS Contrast?	N/A
N/A	Landing Slope (%)	N/A	N/A	DWS Length (in)	N/A
N/A	Landing X Slope (%)	N/A	N/A	DWS Full Width?	N/A
N/A	Landing Curb? (Y/N)	N/A	N/A	DWS Offset (in)	N/A
N/A	Shared Landing?	N/A			
N/A	Gutter Ponding?	N/A	N/A	Gutter Slope (%)	N/A
N/A	Gutter Lip Ht (in)	N/A	N/A	Gutter X Slope (%)	N/A
N/A	Painted X Walk1?	Yes	N/A	Painted X Walk2?	Yes
	X Walk 1 Direction	To SW		X Walk 2 Direction	To SE
N/A	X Walk 1 Width (in)	115.0	N/A	X Walk 2 Width (in)	112.0
	X Walk 1 Slope (%)	1.5		X Walk 2 Slope (%)	0.1
	X Walk 1 X Slope (%)	3.5		X Walk 2 X Slope (%)	4.0

N/A	Ramp inside XWalk1?	Yes	N/A	Ramp inside XWalk2?	Yes
	Road Slope (%)	4.6	N/A	Clear Space?	N/A
	Road X Slope (%)	3.5	N/A	Clear Space to XWalk (in)	N/A
N/A	Any Obstructions?	N/A	N/A	Storm Grate/Utility Hazard?	N/A
	Obstruction Type			Storm Grate/Utility Type	
		N/A			N/A
		Yes		Surface Condition? (G/P)	Good

**Remove & Replace Curb Ramp With Two New Directional Ramps or Equivalent.**

**R304.5.1, R304.2.2, R304.5.3**
