# Access Compliance Report

## Public Rights-of-Way

### (Curb Ramps)

| Intersection ID: 8041 | | Main Street: AUSTIN_DR | | Cross Street: N_TRYON_ST | | Location: | | NW | |

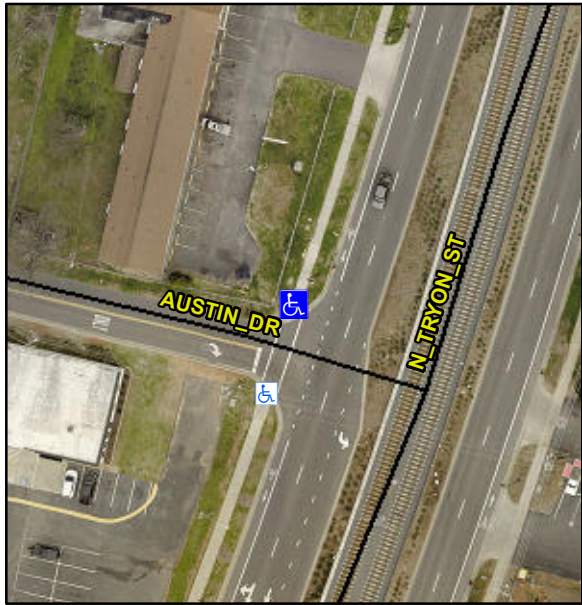
| ADA ID: 61665BFACDB9 | | Ramp Type: Directional1 | | Initial Pass/Fail: Pass | | Overall Compliance: No | | Severity Score: 15 | |
| | | | | Yes | Ramp Slope (%) | 8.2 | No | Grade Break XSlope (%) | 2.9 |
| | | | | No | Landing Slope (%) | 3.2 | Yes | DWS Length (in) | 24.0 |
| | | | | No | Gutter Lip Ht (in) | 1.5 | No | Gutter X Slope (%) | 4.6 |

| <div></div> <div>Possible Solutions:</div> <div>Remove &amp; Replace Entire Ramp.<br/>Remove &amp; Replace Gutter.</div> <div>Surveyor Notes:</div> <div>N/A</div> <div>PROW/ADA:</div> <div>R304.2.2-Perp, R304.3.2-Para,<br/>R304.5.3, R305.2, R302.7.2</div> <div>Street 1 Name</div> <div>AUSTIN DR</div> <div>Stop Condition-Street 1</div> <div>StopSign</div> <div>Street 2 Name</div> <div>N/A</div> <div>Stop Condition-Street 2</div> <div>N/A</div> <div>Total Cost:</div> <div>\$</div> <div>2350.00</div> | | | | Compliance | Description | Data | Compliance | Description | Data |
