# Access Compliance Report

## Public Rights-of-Way

### (Curb Ramps)

| Intersection ID: 47283 | Main Street: REIDHAVEN_ST | Cross Street: NETTLETON_CT | Location: SW |

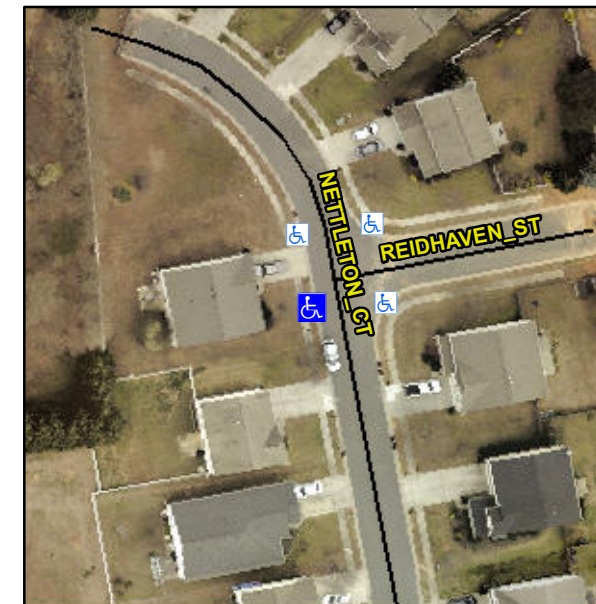
**Not Found, R304.5.1, R304.5.3**

| Compliance | Description | Data | Compliance | Description | Data |
|---|---|---|---|---|---|
| N/A | Ramp Length (in) | 47.5 | Yes | Ramp Slope (%) | 7.8 |
| No | Ramp Width (in) | 39.5 | No | Ramp XSlope (%) | 2.7 |

**Remove & Replace Entire Ramp.**

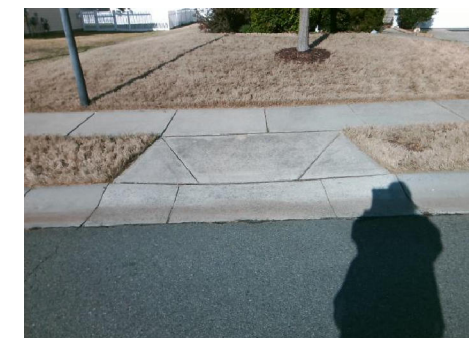
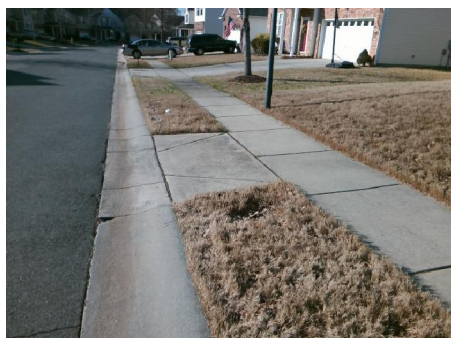
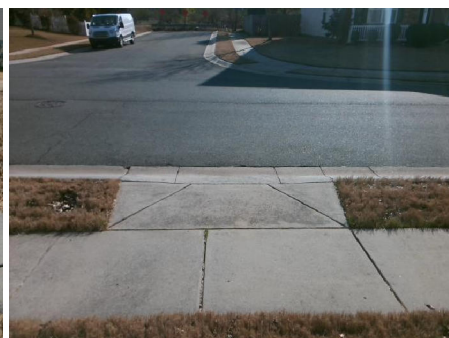
| Compliance | Description | Data | Compliance | Description | Data |
|---|---|---|---|---|---|
| | | | Yes | Surface Condition? (G/P) | Good |
