Intersection ID: 15510	Main Street: COTTAGE_PL	Cross Street: PROVIDENCE_RD	Location:	NE
ADA ID: 6170A55AFFD9	Ramp Type: PerpDiag	Initial Pass/Fail: Fail	Overall Compliance: No	Severity Score: 21.25

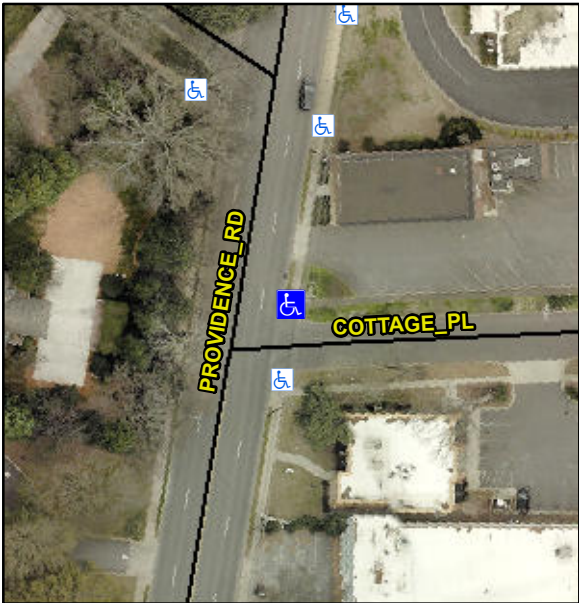
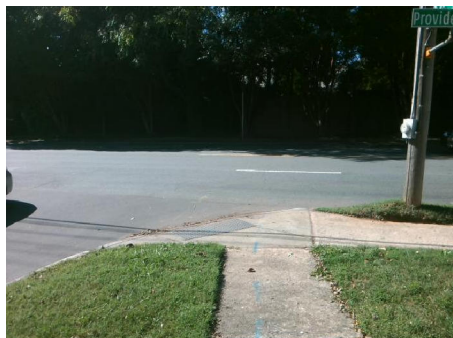
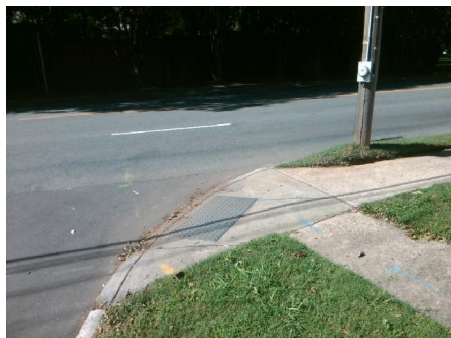
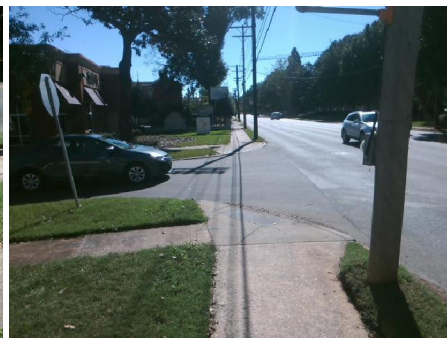
Possible Solutions:		Compliance	Description	Data	Compliance	Description	Data
	Remove & Replace Curb Ramp With Two New Directional Ramps or Equivalent.		N/A	Ramp Length (in)	55.0	No	Ramp Slope (%)	9.4
			No	Ramp Width (in)	47.0	Yes	Ramp XSlope (%)	1.6
			N/A	Flare Type LT	N/A	N/A	Flare Type RT	N/A
			N/A	Flare Slope LT (%)	N/A	N/A	Flare Slope RT (%)	N/A
			N/A	Flare Traversable LT?	N/A	N/A	Flare Traversable RT?	N/A
			N/A	Landing Length (in)	N/A	N/A	DWS Provided?	N/A
			N/A	Landing Width (in)	N/A	N/A	DWS Contrast?	N/A
			N/A	Landing Slope (%)	N/A	N/A	DWS Length (in)	N/A
			N/A	Landing X Slope (%)	N/A	N/A	DWS Full Width?	N/A
Surveyor Notes:		N/A	N/A	Landing Curb? (Y/N)	N/A	N/A	DWS Offset (in)	N/A
			N/A	Shared Landing?	N/A			
PROW/ADA:		N/A	N/A	Gutter Ponding?	N/A	N/A	Gutter Slope (%)	N/A
Not Found, R304.5.1, R304.2.2			N/A	Gutter Lip Ht (in)	N/A	N/A	Gutter X Slope (%)	N/A

N/A	Painted X Walk1?	No	N/A	Painted X Walk2?	No
				X Walk 1 Direction	To W		X Walk 2 Direction	To SW
			N/A	X Walk 1 Width (in)	N/A	N/A	X Walk 2 Width (in)	N/A
				X Walk 1 Slope (%)	4.1		X Walk 2 Slope (%)	0.1
				X Walk 1 X Slope (%)	3.0		X Walk 2 X Slope (%)	2.4
			N/A	Ramp inside XWalk1?	N/A	N/A	Ramp inside XWalk2?	N/A
				Road Slope (%)	1.3	N/A	Clear Space?	N/A
				Road X Slope (%)	3.4	N/A	Clear Space to XWalk (in)	N/A
			N/A	Any Obstructions?	N/A	N/A	Storm Grate/Utility Hazard?	N/A
				Obstruction Type			Storm Grate/Utility Type	
					N/A			N/A
						Yes	Surface Condition? (G/P)	Good
Total Cost:		\$ 3200.00
