# Access Compliance Report

## Public Rights-of-Way

### (Curb Ramps)

Intersection ID: 24868	Main Street: PARK_RD	Cross Street: PARK_CROSSING_DR	Location: SW
ADA ID: 617211CAD6DE	Ramp Type: PerpDiag	Initial Pass/Fail: Fail	Overall Compliance: No
		Severity Score: 12.5

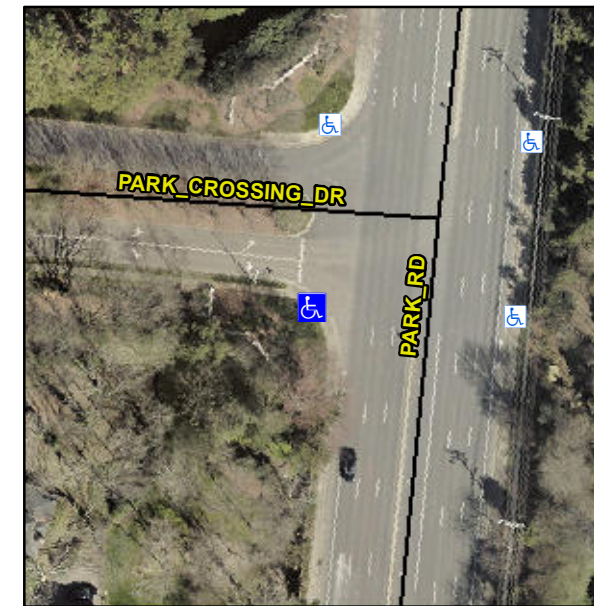
**Not Found, R304.2.2**

Compliance	Description	Data	Compliance	Description	Data
N/A	Ramp Length (in)	60.0	No	Ramp Slope (%)	8.5
Yes	Ramp Width (in)	48.0	Yes	Ramp XSlope (%)	1.4
N/A	Flare Type LT	N/A	N/A	Flare Type RT	N/A
N/A	Flare Slope LT (%)	N/A	N/A	Flare Slope RT (%)	N/A
N/A	Flare Traversable LT?	N/A	N/A	Flare Traversable RT?	N/A
N/A	Landing Length (in)	N/A	N/A	DWS Provided?	N/A
N/A	Landing Width (in)	N/A	N/A	DWS Contrast?	N/A
N/A	Landing Slope (%)	N/A	N/A	DWS Length (in)	N/A
N/A	Landing X Slope (%)	N/A	N/A	DWS Full Width?	N/A
N/A	Landing Curb? (Y/N)	N/A	N/A	DWS Offset (in)	N/A
N/A	Shared Landing?	N/A			
N/A	Gutter Ponding?	N/A	N/A	Gutter Slope (%)	N/A
N/A	Gutter Lip Ht (in)	N/A	N/A	Gutter X Slope (%)	N/A
N/A	Painted X Walk1?	No	N/A	Painted X Walk2?	No
	X Walk 1 Direction	To SE		X Walk 2 Direction	To NE
N/A	X Walk 1 Width (in)	N/A	N/A	X Walk 2 Width (in)	N/A
	X Walk 1 Slope (%)	2.8		X Walk 2 Slope (%)	3.4
	X Walk 1 X Slope (%)	2.6		X Walk 2 X Slope (%)	3.3

N/A	Ramp inside XWalk1?	N/A	N/A	Ramp inside XWalk2?	N/A
	Road Slope (%)	1.3	N/A	Clear Space?	N/A
	Road X Slope (%)	3.7	N/A	Clear Space to XWalk (in)	N/A
N/A	Any Obstructions?	N/A	N/A	Storm Grate/Utility Hazard?	N/A
	Obstruction Type			Storm Grate/Utility Type	
		N/A			N/A
			Yes	Surface Condition? (G/P)	Good

**Remove & Replace Curb Ramp With Two New Directional Ramps or Equivalent.**
