# Access Compliance Report

## Public Rights-of-Way

### (Curb Ramps)

| Intersection ID: 5199 | Main Street: N_TRYON_ST | Cross Street: BARTON_CREEK_DR | Location: NW |

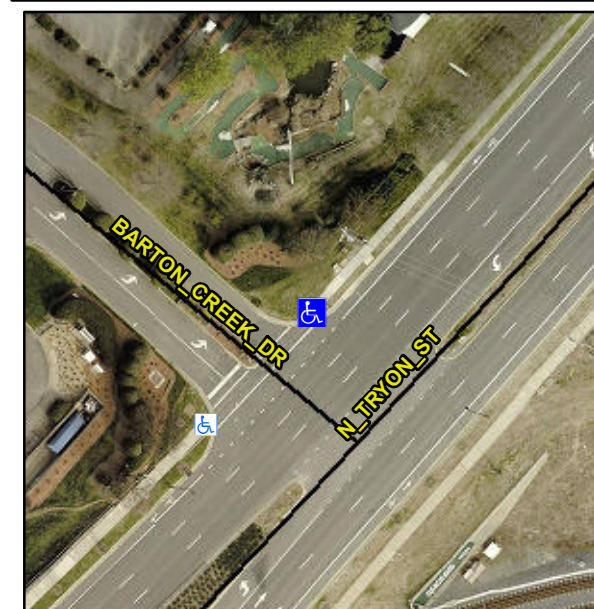
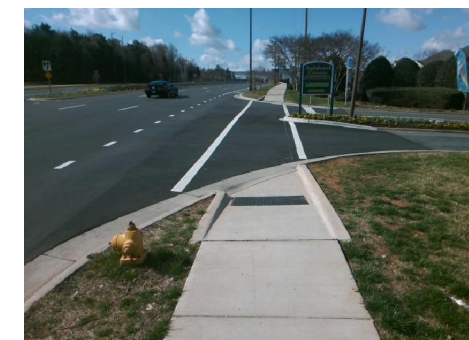
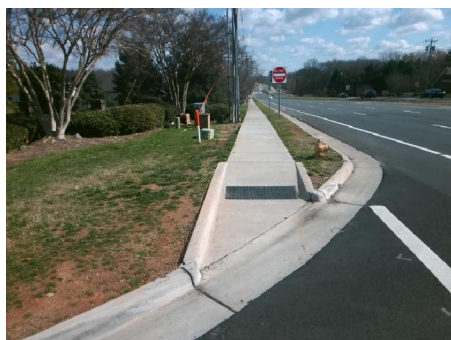
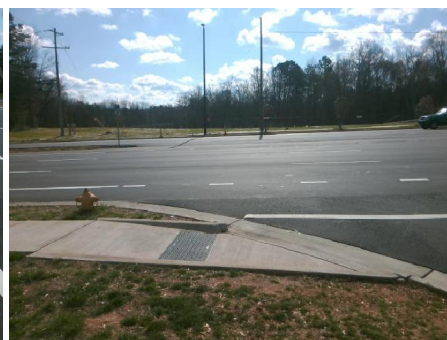
| ADA ID: 617573942AFC | Ramp Type: Directional1 | Initial Pass/Fail: Fail | Overall Compliance: No |
| Severity Score: 1.25 | | | |

**R304.5.3**

| Compliance | Description | Data | Compliance | Description | Data |
|---|---|---|---|---|---|
| No | Ramp XSlope (%) | 2.2 | | | |

**Remove & Replace Entire Ramp.**

\$ 1600.00
