Access Compliance Report

Public Rights-of-Way

(Curb Ramps)

Intersection ID: 53212	Main Street: IDLEWILD_RD	Cross Street: N/A	Location: NE
ADA ID: 61771145E4F3	Ramp Type: Directional1	Initial Pass/Fail: Pass	Overall Compliance: No
		Severity Score: 0.25

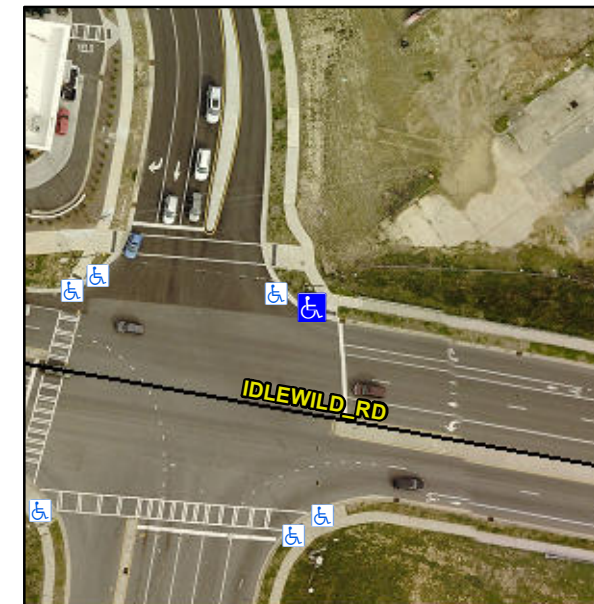
Compliance	Description	Data	Compliance	Description	Data
N/A	Ramp Length (in)	61.0	Yes	Grade Break?	Yes
Yes	Ramp Width (in)	71.0	Yes	Grade Break Slope (%)	0.4
Yes	Ramp Slope (%)	4.1	Yes	Grade Break XSlope (%)	0.5
Yes	Ramp XSlope (%)	4.0			
Yes	Flare Type LT	N/A	Yes	Flare Type RT	N/A
N/A	Flare Slope LT (%)	N/A	N/A	Flare Slope RT (%)	N/A
N/A	Flare Traversable LT?	No	N/A	Flare Traversable RT?	No
Yes	Landing Length (in)	70.0	Yes	DWS Provided?	Yes
Yes	Landing Width (in)	71.0	Yes	DWS Contrast?	Yes
Yes	Landing Slope (%)	1.3	Yes	DWS Length (in)	24.0
Yes	Landing X Slope (%)	1.9	Yes	DWS Full Width?	Yes
N/A	Landing Curb? (Y/N)	No	Yes	DWS Offset LT (in)	1.0
N/A	Shared Landing?	No	Yes	DWS Offset RT (in)	7.0
Yes	Gutter Ponding?	No	Yes	Gutter Slope (%)	1.2
Yes	Gutter Lip Ht (in)	0.0	No	Gutter X Slope (%)	4.7
N/A	Painted X Walk1?	No		Road Slope (%)	0.3
	X Walk 1 Direction	To S		Road X Slope (%)	4.4
	X Walk 1 Width (in)	N/A		Clear Space?	Yes

X Walk 1 Slope (%)	0.3	N/A	Clear Space to XWalk (in)	N/A
	X Walk 1 X Slope (%)	4.4	Yes	Storm Grate/Utility Hazard?	No
N/A	Ramp inside XWalk1?	N/A		Storm Grate/Utility Type	
Yes	Any Obstructions?	No			N/A
	Obstruction Type		Yes	Surface Condition? (G/P)	Good
			N/A	Curb Slope (%)	1.1

Remove & Replace Gutter.

R304.5.3
