Access Compliance Report

Public Rights-of-Way

(Curb Ramps)

Intersection ID: 53894	Main Street: INVERNESS_BAY_RD	Cross Street: PERTH_MOOR_RD	Location: NE
ADA ID: 617E4A31F835	Ramp Type: Perp	Initial Pass/Fail: Fail	Overall Compliance: No
			Severity Score: 21.25

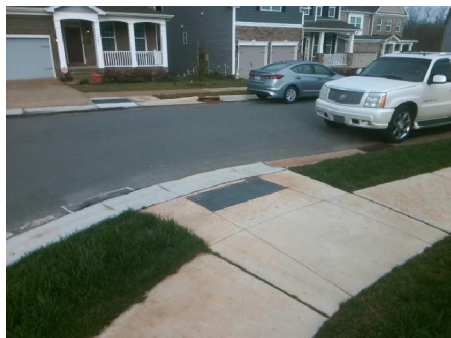
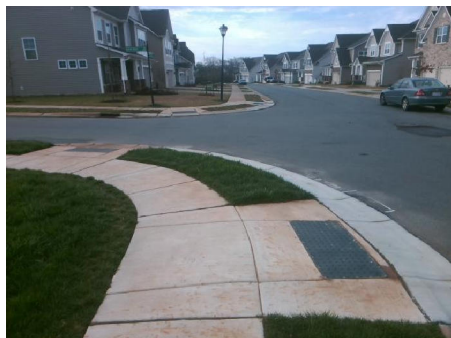
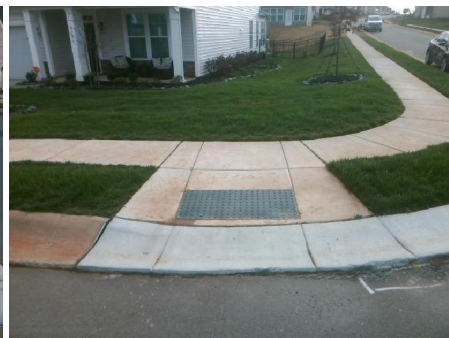
Possible Solutions:		Compliance	Description	Data	Compliance	Description	Data
	Remove & Replace Entire Ramp.		N/A	Ramp Length (in)	51.0	No	Ramp Slope (%)	9.2
			No	Ramp Width (in)	46.5	Yes	Ramp XSlope (%)	0.5
			N/A	Flare Type LT	N/A	N/A	Flare Type RT	N/A
			N/A	Flare Slope LT (%)	N/A	N/A	Flare Slope RT (%)	N/A
			N/A	Flare Traversable LT?	N/A	N/A	Flare Traversable RT?	N/A
			N/A	Landing Length (in)	N/A	N/A	DWS Provided?	N/A
			N/A	Landing Width (in)	N/A	N/A	DWS Contrast?	N/A
			N/A	Landing Slope (%)	N/A	N/A	DWS Length (in)	N/A
			N/A	Landing X Slope (%)	N/A	N/A	DWS Full Width?	N/A
Surveyor Notes:	N/A		N/A	Landing Curb? (Y/N)	N/A	N/A	DWS Offset (in)	N/A
			N/A	Shared Landing?	N/A			
	PROW/ADA:		N/A	Gutter Ponding?	N/A	N/A	Gutter Slope (%)	N/A
	Not Found, R304.5.1, R304.2.2		N/A	Gutter Lip Ht (in)	1.0	N/A	Gutter X Slope (%)	N/A

N/A	Painted X Walk1?	No	N/A	Painted X Walk2?	N/A
				X Walk 1 Direction	To W		X Walk 2 Direction	N/A
			N/A	X Walk 1 Width (in)	N/A	N/A	X Walk 2 Width (in)	N/A
				X Walk 1 Slope (%)	1.3		X Walk 2 Slope (%)	N/A
				X Walk 1 X Slope (%)	2.7		X Walk 2 X Slope (%)	N/A
			N/A	Ramp inside XWalk1?	N/A	N/A	Ramp inside XWalk2?	N/A
			Road Slope (%)	N/A	N/A	Clear Space?	N/A	
			Road X Slope (%)	N/A	N/A	Clear Space to XWalk (in)	N/A	
		N/A	Any Obstructions?	N/A	N/A	Storm Grate/Utility Hazard?	N/A	
			Obstruction Type			Storm Grate/Utility Type		
					N/A		N/A	
						Yes	Surface Condition? (G/P)	Good
