Access Compliance Report

Public Rights-of-Way

(Curb Ramps)

Intersection ID: 13502	Main Street: WEST_BV	Cross Street: WILMORE_DR	Location: SW
ADA ID: 6183313904B5	Ramp Type: PerpDiag	Initial Pass/Fail: Fail	Overall Compliance: No
Codes/Mitigation Info/Possible Solution		Field Measurements/Component Compliance

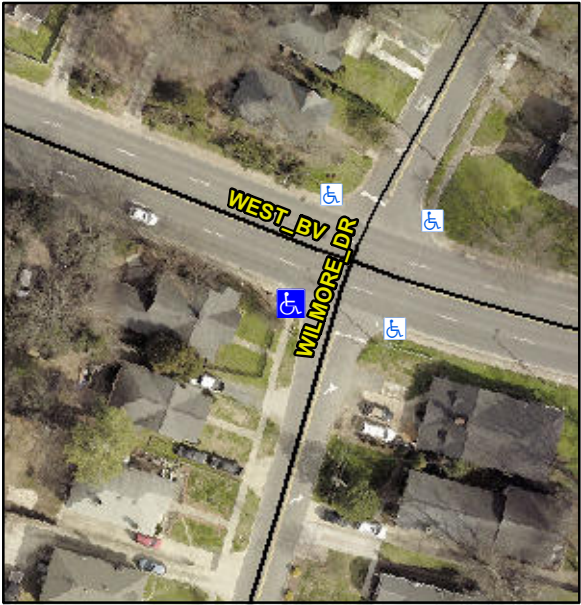
Possible Solutions:						
	Remove & Replace Curb Ramp With Two New Directional Ramps or Equivalent.						
	Surveyor Notes:						
	N/A						
	PROW/ADA:						
	Not Found, R304.5.1, R304.5.3						
Street 1 Name	WILMORE DR	Compliance	Description	Data	Compliance	Description	Data
Stop Condition-Street 2	StopSign	N/A	Ramp Length (in)	58.0	Yes	Ramp Slope (%)	6.2
Street 2 Name	WEST BV	No	Ramp Width (in)	36.0	No	Ramp XSlope (%)	12.2
Stop Condition-Street 1	None	N/A	Flare Type LT	N/A	N/A	Flare Type RT	N/A
		N/A	Flare Slope LT (%)	N/A	N/A	Flare Slope RT (%)	N/A
		N/A	Flare Traversable LT?	N/A	N/A	Flare Traversable RT?	N/A
		N/A	Landing Length (in)	N/A	N/A	DWS Provided?	N/A
		N/A	Landing Width (in)	N/A	N/A	DWS Contrast?	N/A
		N/A	Landing Slope (%)	N/A	N/A	DWS Length (in)	N/A
		N/A	Landing X Slope (%)	N/A	N/A	DWS Full Width?	N/A
		N/A	Landing Curb? (Y/N)	N/A	N/A	DWS Offset (in)	N/A
		N/A	Shared Landing?	N/A			
		N/A	Gutter Ponding?	N/A	N/A	Gutter Slope (%)	N/A

N/A	Gutter Lip Ht (in)	N/A	N/A	Gutter X Slope (%)	N/A
		N/A	Painted X Walk1?	No	N/A	Painted X Walk2?	No
			X Walk 1 Direction	To SE		X Walk 2 Direction	To NE
		N/A	X Walk 1 Width (in)	N/A	N/A	X Walk 2 Width (in)	N/A
			X Walk 1 Slope (%)	0.8		X Walk 2 Slope (%)	0.9
			X Walk 1 X Slope (%)	3.9		X Walk 2 X Slope (%)	0.7
		N/A	Ramp inside XWalk1?	N/A	N/A	Ramp inside XWalk2?	N/A
			Road Slope (%)	3.8	N/A	Clear Space?	N/A
			Road X Slope (%)	3.5	N/A	Clear Space to XWalk (in)	N/A
		N/A	Any Obstructions?	N/A	N/A	Storm Grate/Utility Hazard?	N/A
			Obstruction Type			Storm Grate/Utility Type	
					N/A		N/A
					Yes	Surface Condition? (G/P)	Good
Total Cost:		\$ 3200.00
