# Access Compliance Report

## Public Rights-of-Way

### (Curb Ramps)

Intersection ID: N/A	Main Street: MORRISON_BV	Cross Street: SOUTH_PARK_DR	Location: NW
ADA ID: 6188121244FF	Ramp Type: Perp	Initial Pass/Fail: Fail	Overall Compliance: No
Severity Score: 22.5			
Codes/Mitigation Info/Possible Solution		Field Measurements/Component Compliance

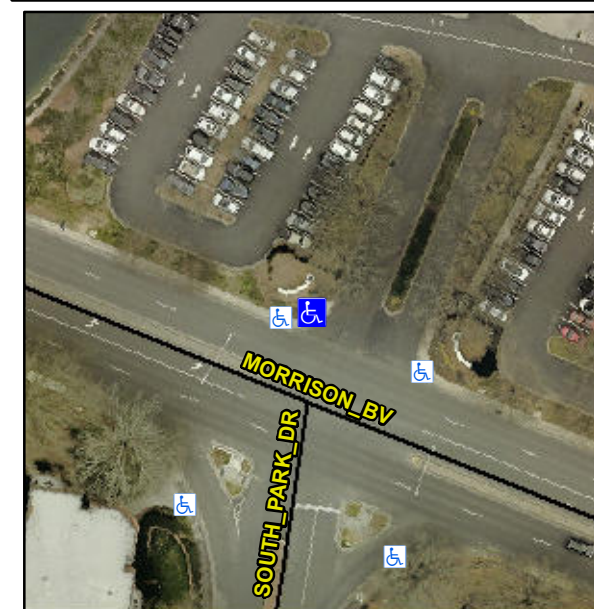
**Not Found, R304.5.1, R304.2.2, R304.5.3**

Compliance	Description	Data	Compliance	Description	Data
N/A	Ramp Length (in)	48.0	No	Ramp Slope (%)	9.5
No	Ramp Width (in)	47.0	No	Ramp XSlope (%)	3.8
N/A	Flare Type LT	N/A	N/A	Flare Type RT	N/A
N/A	Flare Slope LT (%)	N/A	N/A	Flare Slope RT (%)	N/A
N/A	Flare Traversable LT?	N/A	N/A	Flare Traversable RT?	N/A
N/A	Landing Length (in)	N/A	N/A	DWS Provided?	N/A
N/A	Landing Width (in)	N/A	N/A	DWS Contrast?	N/A
N/A	Landing Slope (%)	N/A	N/A	DWS Length (in)	N/A
N/A	Landing X Slope (%)	N/A	N/A	DWS Full Width?	N/A
N/A	Landing Curb? (Y/N)	N/A	N/A	DWS Offset (in)	N/A
N/A	Shared Landing?	N/A			
N/A	Gutter Ponding?	N/A	N/A	Gutter Slope (%)	N/A
N/A	Gutter Lip Ht (in)	N/A	N/A	Gutter X Slope (%)	N/A
N/A	Painted X Walk1?	No	N/A	Painted X Walk2?	N/A
	X Walk 1 Direction	To E		X Walk 2 Direction	N/A
N/A	X Walk 1 Width (in)	N/A	N/A	X Walk 2 Width (in)	N/A
	X Walk 1 Slope (%)	6.0		X Walk 2 Slope (%)	N/A
	X Walk 1 X Slope (%)	1.6		X Walk 2 X Slope (%)	N/A

Possible Solutions:

**Remove & Replace Entire Ramp.**
