Access Compliance Report

Public Rights-of-Way

(Curb Ramps)

Intersection ID: 50599	Main Street: HEARTLEAF_RD	Cross Street: STREAM_ORCHID_LN	Location: SW
ADA ID: 618C0AE45C89	Ramp Type: BlendTrans1	Initial Pass/Fail: Pass	Overall Compliance: No
		Severity Score: 5

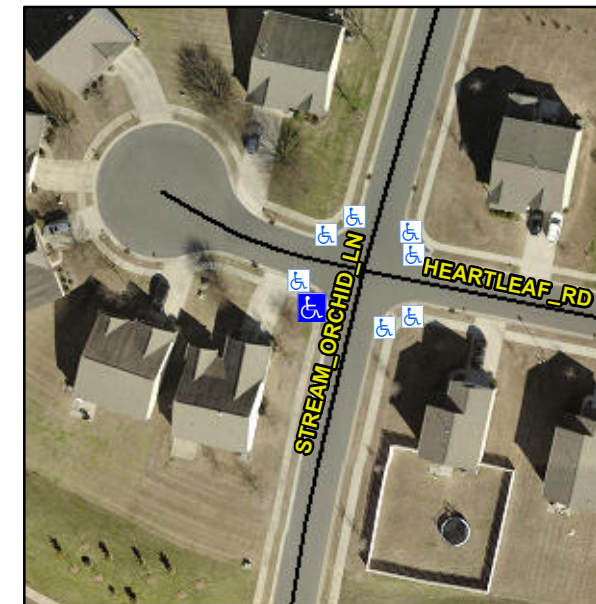
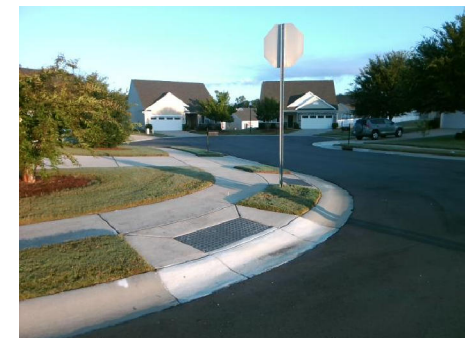
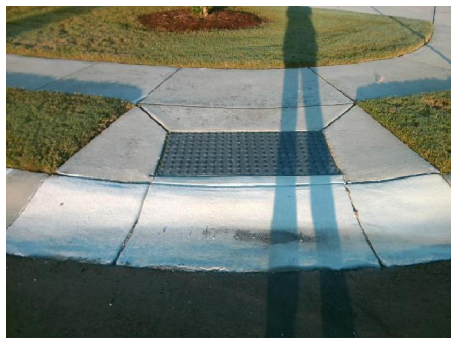
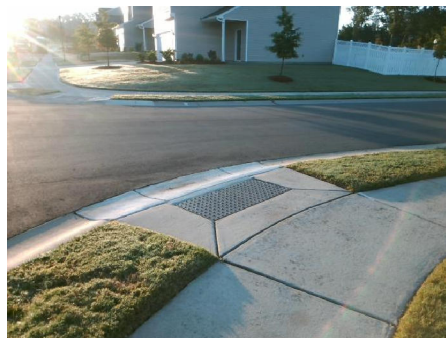
Not Found, R305.2, R302.7, R304.5.4

Compliance	Description	Data	Compliance	Description	Data
N/A	Ramp Length (in)	47.0	Yes	BlendTrans Slope (%)	5.0
Yes	Ramp Width (in)	48.0	Yes	BlendTrans XSlope (%)	0.5
N/A	Flare Type LT	Sloped	N/A	Flare Type RT	Sloped
N/A	Flare Slope LT (%)	2.5	N/A	Flare Slope RT (%)	5.3
N/A	Flare Traversable LT?	No	N/A	Flare Traversable RT?	No
Yes	Landing Length (in)	48.0	Yes	DWS Provided?	Yes
Yes	Landing Width (in)	61.0	Yes	DWS Contrast?	Yes
Yes	Landing Slope (%)	0.8	Yes	DWS Length (in)	24.0
Yes	Landing X Slope (%)	0.4	Yes	DWS Full Width?	Yes
N/A	Landing Curb? (Y/N)	No	No	DWS Offset (in)	5.5
N/A	Shared Landing?	Yes			
No	Gutter Ponding?	Yes	No	Gutter Slope (%)	5.8
Yes	Gutter Lip Ht (in)	0.0	Yes	Gutter X Slope (%)	0.4
N/A	Painted X Walk1?	No	N/A	Painted X Walk2?	N/A
	X Walk 1 Direction	To E		X Walk 2 Direction	N/A
	X Walk 1 Width (in)	N/A		X Walk 2 Width (in)	N/A
	X Walk 1 Slope (%)	2.2		X Walk 2 Slope (%)	N/A
	X Walk 1 X Slope (%)	0.9		X Walk 2 X Slope (%)	N/A

N/A	Ramp inside XWalk1?	N/A	N/A	Ramp inside XWalk2?	N/A
	Road Slope (%)	0.9		Clear Space?	Yes
	Road X Slope (%)	2.2	N/A	Clear Space to XWalk (in)	N/A
Yes	Any Obstructions?	No	Yes	Storm Grate/Utility Hazard?	No
	Obstruction Type			Storm Grate/Utility Type	
		N/A			N/A
			Yes	Surface Condition? (G/P)	Good
			No	Curb Slope (%)	27.2

Possible Solutions:

Remove & Replace Curb Ramp With Two New Directional Ramps or Equivalent. Remove & Replace Gutter.
