# Access Compliance Report

## Public Rights-of-Way

### (Curb Ramps)

| Intersection ID: 42476 | Main Street: SIR_CHARLES_PL | Cross Street: HARRISON_STEEL_DR | Location: SE |

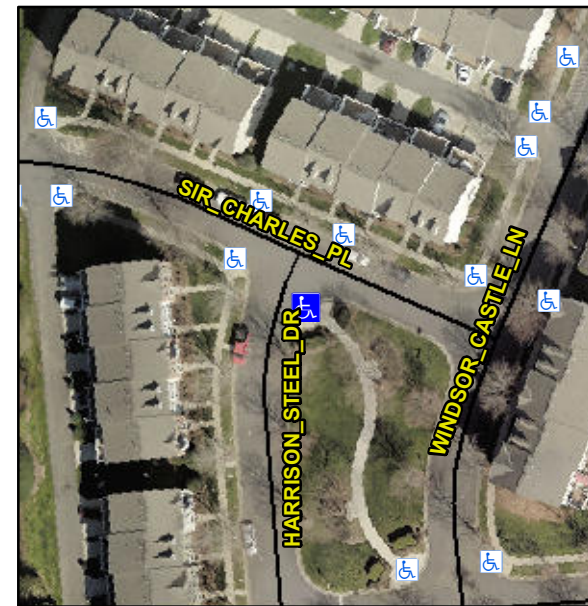
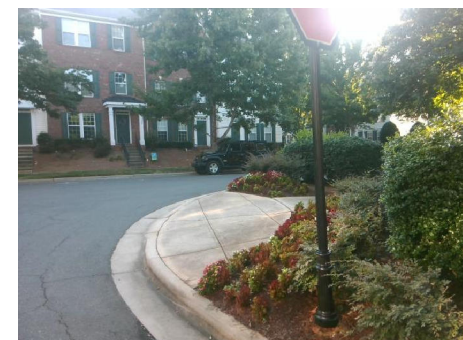
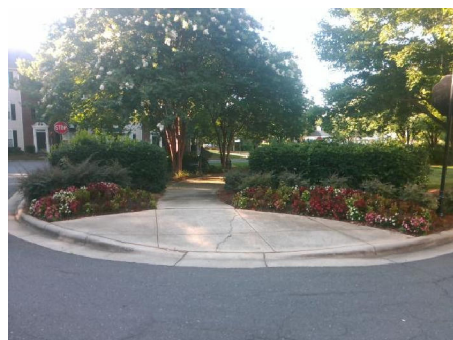
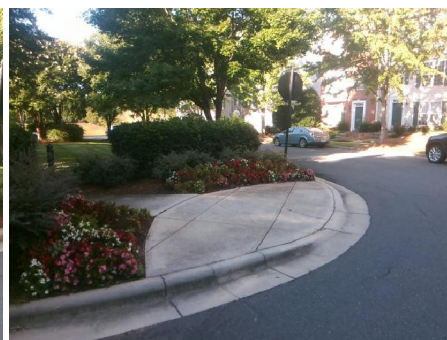
**R304.2.2, R304.5.3**

| Compliance | Description | Data | Compliance | Description | Data |
|---|---|---|---|---|---|
| N/A | Ramp Length (in) | 106.0 | No | Ramp Slope (%) | 8.6 |
| Yes | Ramp Width (in) | 48.0 | No | Ramp XSlope (%) | 3.8 |

**Remove & Replace Curb Ramp With Two New Directional Ramps or Equivalent.**
