# Access Compliance Report

## Public Rights-of-Way

| Intersection ID: 10028229 | Main Street: HEATHSTEAD_PL | Cross Street: N/A | Location: NE |
| ADA ID: 6192FD9B8976 | Ramp Type: PerpDiag | Initial Pass/Fail: Fail | Overall Compliance: No |

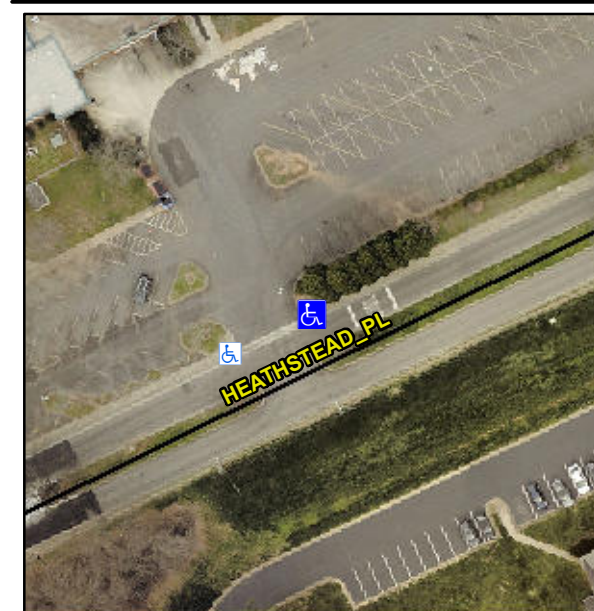
**Not Found, R304.5.1, R304.2.2, R304.5.3**

| Compliance | Description | Data | Compliance | Description | Data |
|---|---|---|---|---|---|
| N/A | Ramp Length (in) | 60.0 | No | Ramp Slope (%) | 8.6 |
| No | Ramp Width (in) | 26.0 | No | Ramp XSlope (%) | 7.8 |

Possible Solutions:

**Remove & Replace Curb Ramp With Two New Directional Ramps or Equivalent.**
