Access Compliance Report

Public Rights-of-Way

(Curb Ramps)

| Intersection ID: 23481 | Main Street: ALEXANDER_RD | Cross Street: PROVIDENCE_RD | Location: NE |

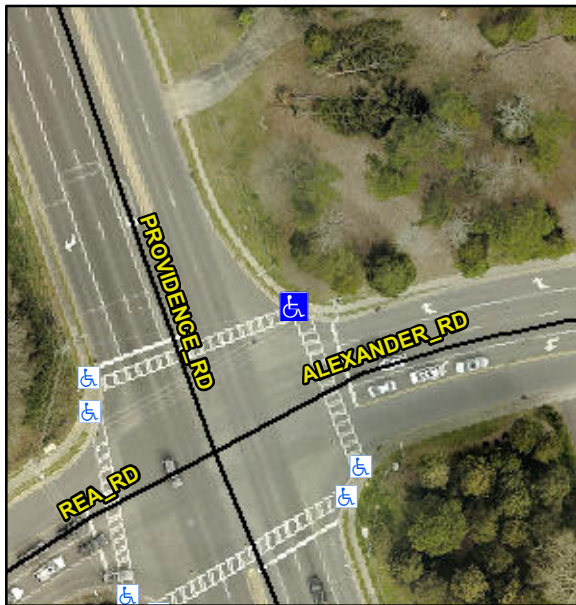
Not Found, R304.2.2

| Compliance | Description | Data | Compliance | Description | Data |
|---|---|---|---|---|---|
| N/A | Ramp Length (in) | 70.0 | No | Ramp Slope (%) | 8.8 |

Remove & Replace Curb Ramp With Two New Directional Ramps or Equivalent.

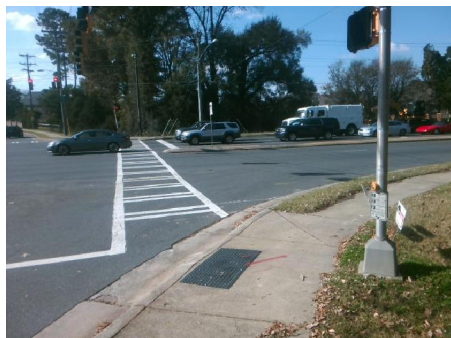
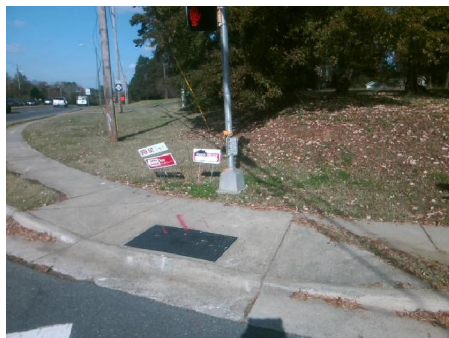
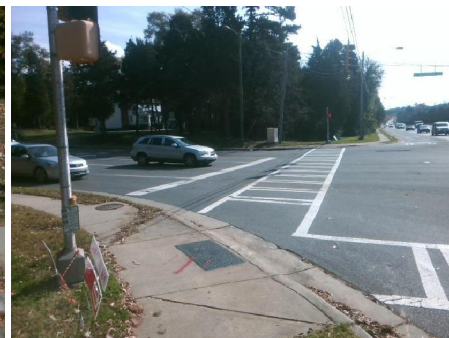
| ADA ID: 619638EE4739 | Ramp Type: PerpDiag | Initial Pass/Fail: Fail | Overall Compliance: No |
