# Access Compliance Report

## Public Rights-of-Way

### (Curb Ramps)

| Intersection ID: 28068 | Main Street: BORCHETTA_DR | Cross Street: MITCHELL_GLEN_DR | Location: NW |

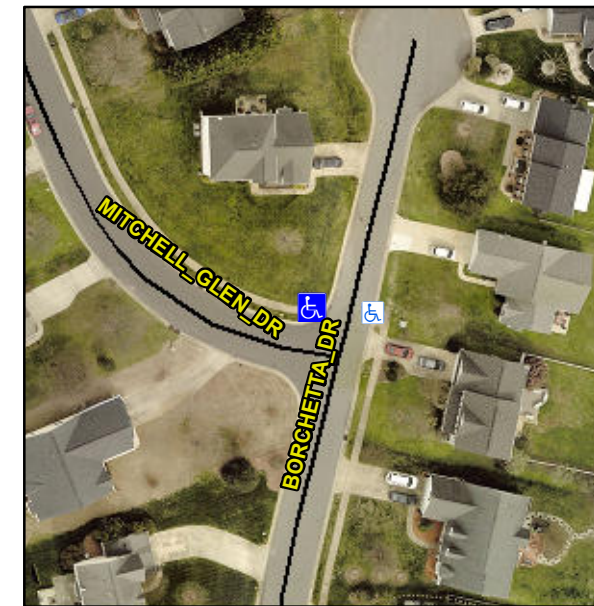
| ADA ID: 61A66F9EF1F6 | Ramp Type: BlendTrans2 | Initial Pass/Fail: Fail | Overall Compliance: No |
| | | Severity Score: 25 | |

**Not Found, R304.5.3**

| Compliance | Description | Data | Compliance | Description | Data |
|---|---|---|---|---|---|
| Yes | Ramp Width (in) | 48.0 | No | BlendTrans XSlope (%) | 9.2 |
| | | | No | Curb Slope (%) | 6.6 |

**Remove & Replace Curb Ramp With Two New Directional Ramps or Equivalent.**

Total Cost: \$ 3200.00
