# Access Compliance Report

## Public Rights-of-Way

### (Curb Ramps)

| Intersection ID: 47847 | Main Street: ALVARADO_WY | Cross Street: CACTUS_VALLEY_RD | Location: SW |

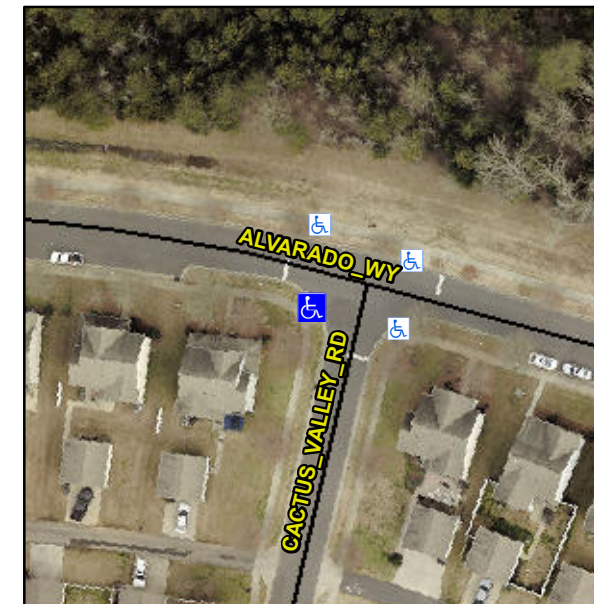
**Not Found, R304.5.1, R304.2.2**

| Compliance | Description | Data | Compliance | Description | Data |
|---|---|---|---|---|---|
| N/A | Ramp Length (in) | 84.0 | No | Ramp Slope (%) | 9.3 |
| No | Ramp Width (in) | 39.0 | Yes | Ramp XSlope (%) | 2.0 |

**Remove & Replace Curb Ramp With Two New Directional Ramps or Equivalent.**

Total Cost: \$ 3200.00
