Access Compliance Report

Public Rights-of-Way

(Curb Ramps)

Intersection ID: 11676	Main Street: HAWTHORNE_LN	Cross Street: PARKWOOD_AV	Location: NE
ADA ID: 61AB69987660	Ramp Type: Perp	Initial Pass/Fail: Fail	Overall Compliance: No
		Severity Score: 10

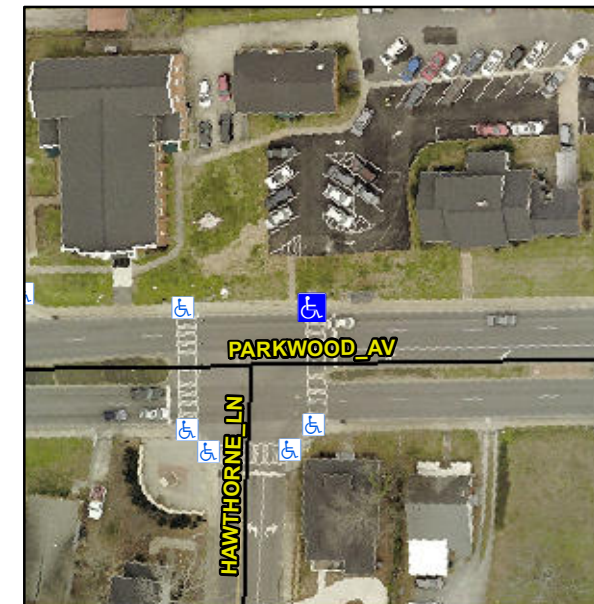
Not Found, R304.5.1

Compliance	Description	Data	Compliance	Description	Data
N/A	Ramp Length (in)	60.0	Yes	Ramp Slope (%)	7.4
No	Ramp Width (in)	47.5	Yes	Ramp XSlope (%)	2.3
N/A	Flare Type LT	N/A	N/A	Flare Type RT	N/A
N/A	Flare Slope LT (%)	N/A	N/A	Flare Slope RT (%)	N/A
N/A	Flare Traversable LT?	N/A	N/A	Flare Traversable RT?	N/A
N/A	Landing Length (in)	N/A	N/A	DWS Provided?	N/A
N/A	Landing Width (in)	N/A	N/A	DWS Contrast?	N/A
N/A	Landing Slope (%)	N/A	N/A	DWS Length (in)	N/A
N/A	Landing X Slope (%)	N/A	N/A	DWS Full Width?	N/A
N/A	Landing Curb? (Y/N)	N/A	N/A	DWS Offset (in)	N/A
N/A	Shared Landing?	N/A			
N/A	Gutter Ponding?	N/A	N/A	Gutter Slope (%)	N/A
N/A	Gutter Lip Ht (in)	N/A	N/A	Gutter X Slope (%)	N/A
N/A	Painted X Walk1?	Yes	N/A	Painted X Walk2?	N/A
	X Walk 1 Direction	To S		X Walk 2 Direction	N/A
N/A	X Walk 1 Width (in)	104.0	N/A	X Walk 2 Width (in)	N/A
	X Walk 1 Slope (%)	2.0		X Walk 2 Slope (%)	N/A
	X Walk 1 X Slope (%)	2.3		X Walk 2 X Slope (%)	N/A

N/A	Ramp inside XWalk1?	Yes	N/A	Ramp inside XWalk2?	N/A
	Road Slope (%)	N/A	N/A	Clear Space?	N/A
	Road X Slope (%)	N/A	N/A	Clear Space to XWalk (in)	N/A
N/A	Any Obstructions?	N/A	N/A	Storm Grate/Utility Hazard?	N/A
	Obstruction Type			Storm Grate/Utility Type	
		N/A			N/A
			Yes	Surface Condition? (G/P)	Good

Remove & Replace Entire Ramp.

Total Cost: \$ 1850.00
