Access Compliance Report

Public Rights-of-Way

(Curb Ramps)

Intersection ID: 31277	Main Street: GARRETT_GRIGG_RD	Cross Street: TIGER_LN	Location: E
ADA ID: 61B30720495C	Ramp Type: PerpDiag	Initial Pass/Fail: Fail	Overall Compliance: No
Codes/Mitigation Info/Possible Solution		Field Measurements/Component Compliance	
Severity Score: 8.75

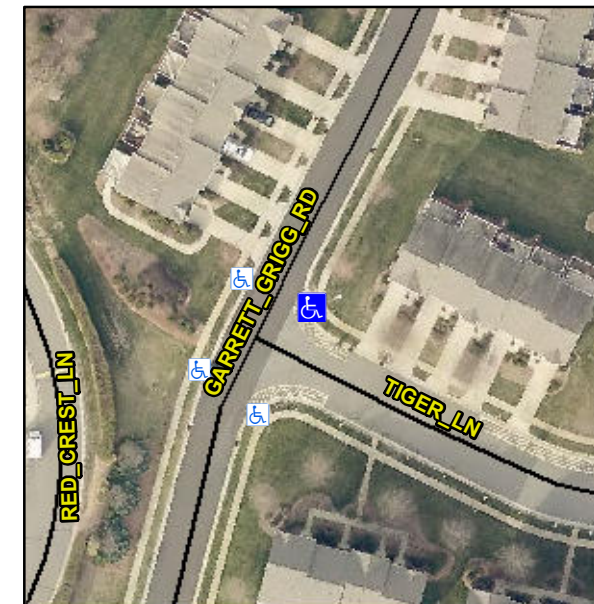
Not Found, R304.5.1

Compliance	Description	Data	Compliance	Description	Data
N/A	Ramp Length (in)	59.0	Yes	Ramp Slope (%)	5.5
No	Ramp Width (in)	39.0	Yes	Ramp XSlope (%)	1.2
N/A	Flare Type LT	N/A	N/A	Flare Type RT	N/A
N/A	Flare Slope LT (%)	N/A	N/A	Flare Slope RT (%)	N/A
N/A	Flare Traversable LT?	N/A	N/A	Flare Traversable RT?	N/A
N/A	Landing Length (in)	N/A	N/A	DWS Provided?	N/A
N/A	Landing Width (in)	N/A	N/A	DWS Contrast?	N/A
N/A	Landing Slope (%)	N/A	N/A	DWS Length (in)	N/A
N/A	Landing X Slope (%)	N/A	N/A	DWS Full Width?	N/A
N/A	Landing Curb? (Y/N)	N/A	N/A	DWS Offset (in)	N/A
N/A	Shared Landing?	N/A			
N/A	Gutter Ponding?	N/A	N/A	Gutter Slope (%)	N/A
N/A	Gutter Lip Ht (in)	N/A	N/A	Gutter X Slope (%)	N/A
N/A	Painted X Walk1?	No	N/A	Painted X Walk2?	No
	X Walk 1 Direction	To NW		X Walk 2 Direction	To SW
N/A	X Walk 1 Width (in)	N/A	N/A	X Walk 2 Width (in)	N/A
	X Walk 1 Slope (%)	4.7		X Walk 2 Slope (%)	4.8
	X Walk 1 X Slope (%)	2.0		X Walk 2 X Slope (%)	0.5

N/A	Ramp inside XWalk1?	N/A	N/A	Ramp inside XWalk2?	N/A
	Road Slope (%)	0.1	N/A	Clear Space?	N/A
	Road X Slope (%)	4.6	N/A	Clear Space to XWalk (in)	N/A
N/A	Any Obstructions?	N/A	N/A	Storm Grate/Utility Hazard?	N/A
	Obstruction Type			Storm Grate/Utility Type	
		N/A			N/A
			Yes	Surface Condition? (G/P)	Good

Possible Solutions:

Remove & Replace Curb Ramp With Two New Directional Ramps or Equivalent.
