Access Compliance Report

Public Rights-of-Way

(Curb Ramps)

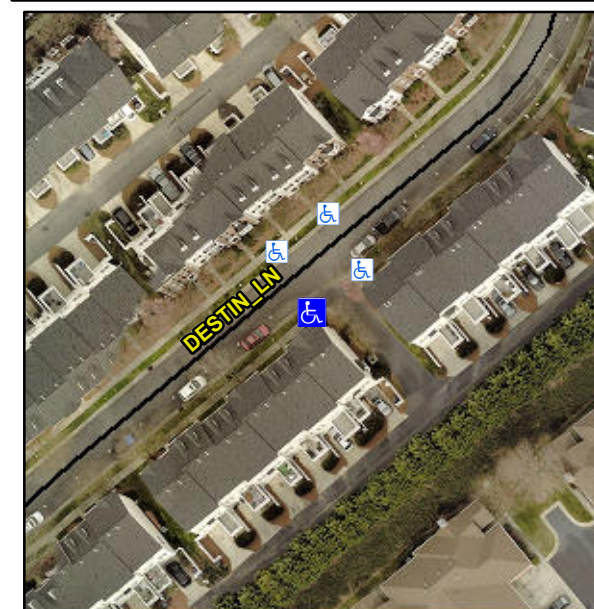
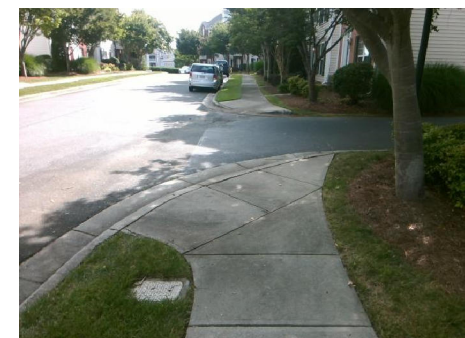
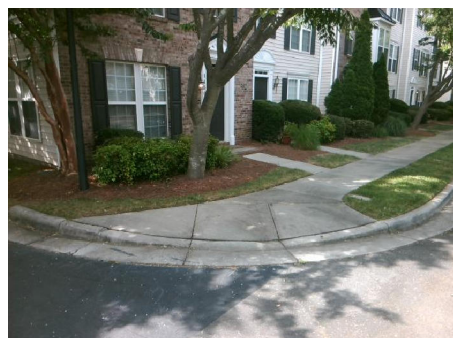
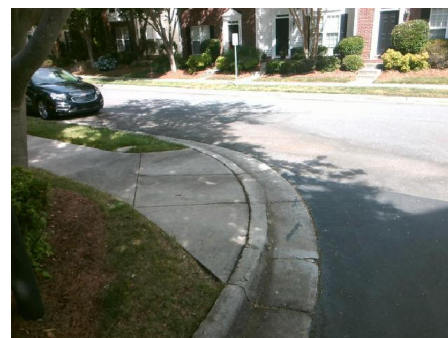
Intersection ID: 10024861	Main Street: DESTIN_LN	Cross Street: N/A	Location: S
ADA ID: 61B9477E9226	Ramp Type: BlendTrans1	Initial Pass/Fail: Fail	Overall Compliance: No
Severity Score: 21.25			
Codes/Mitigation Info/Possible Solution		Field Measurements/Component Compliance

Not Found, R304.5.1, R304.5.3

Compliance	Description	Data	Compliance	Description	Data
N/A	Ramp Length (in)	53.0	Yes	BlendTrans Slope (%)	3.7
No	Ramp Width (in)	43.0	No	BlendTrans XSlope (%)	6.2
N/A	Flare Type LT	N/A	N/A	Flare Type RT	N/A
N/A	Flare Slope LT (%)	N/A	N/A	Flare Slope RT (%)	N/A
N/A	Flare Traversable LT?	N/A	N/A	Flare Traversable RT?	N/A
N/A	Landing Length (in)	N/A	N/A	DWS Provided?	N/A
N/A	Landing Width (in)	N/A	N/A	DWS Contrast?	N/A
N/A	Landing Slope (%)	N/A	N/A	DWS Length (in)	N/A
N/A	Landing X Slope (%)	N/A	N/A	DWS Full Width?	N/A
N/A	Landing Curb? (Y/N)	N/A	N/A	DWS Offset (in)	N/A
N/A	Shared Landing?	N/A			
N/A	Gutter Ponding?	N/A	N/A	Gutter Slope (%)	N/A
N/A	Gutter Lip Ht (in)	N/A	N/A	Gutter X Slope (%)	N/A
N/A	Painted X Walk1?	No	N/A	Painted X Walk2?	No
	X Walk 1 Direction	To NE		X Walk 2 Direction	To NW
	X Walk 1 Width (in)	N/A		X Walk 2 Width (in)	N/A
	X Walk 1 Slope (%)	1.4		X Walk 2 Slope (%)	0.1
	X Walk 1 X Slope (%)	1.0		X Walk 2 X Slope (%)	1.2

N/A	Ramp inside XWalk1?	N/A	N/A	Ramp inside XWalk2?	N/A
	Road Slope (%)	2.4		Clear Space?	N/A
	Road X Slope (%)	1.2	N/A	Clear Space to XWalk (in)	N/A
N/A	Any Obstructions?	N/A	N/A	Storm Grate/Utility Hazard?	N/A
	Obstruction Type			Storm Grate/Utility Type	
		N/A			N/A
			Yes	Surface Condition? (G/P)	Good
			No	Curb Slope (%)	6.0

Remove & Replace Curb Ramp With Two New Directional Ramps or Equivalent.
