Access Compliance Report

Public Rights-of-Way

(Curb Ramps)

Intersection ID: N/A	Main Street: PERIMETER_PY	Cross Street: N/A	Location: SE
ADA ID: 61BE5B141611	Ramp Type: PerpDiag	Initial Pass/Fail: Fail	Overall Compliance: No
		Severity Score: 25

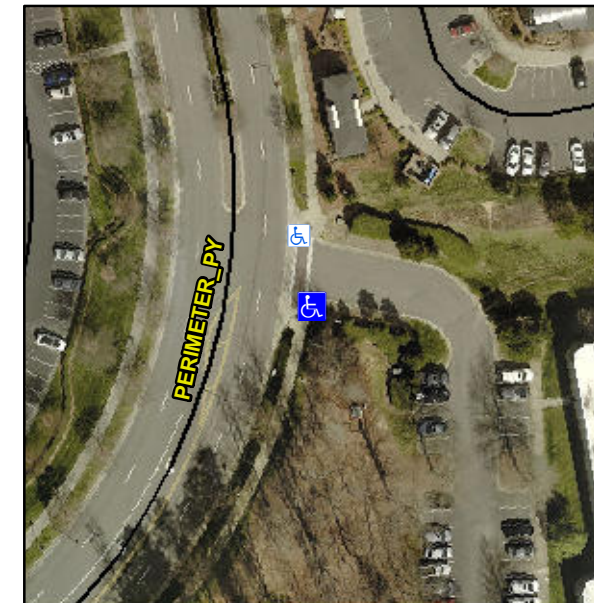
Not Found, R304.5.3

Compliance	Description	Data	Compliance	Description	Data
N/A	Ramp Length (in)	75.0	Yes	Ramp Slope (%)	6.6
Yes	Ramp Width (in)	48.0	No	Ramp XSlope (%)	7.0
N/A	Flare Type LT	N/A	N/A	Flare Type RT	N/A
N/A	Flare Slope LT (%)	N/A	N/A	Flare Slope RT (%)	N/A
N/A	Flare Traversable LT?	No	N/A	Flare Traversable RT?	No
N/A	Landing Length (in)	N/A	N/A	DWS Provided?	N/A
N/A	Landing Width (in)	N/A	N/A	DWS Contrast?	N/A
N/A	Landing Slope (%)	N/A	N/A	DWS Length (in)	N/A
N/A	Landing X Slope (%)	N/A	N/A	DWS Full Width?	N/A
N/A	Landing Curb? (Y/N)	N/A	N/A	DWS Offset (in)	N/A
N/A	Shared Landing?	N/A			
N/A	Gutter Ponding?	N/A	N/A	Gutter Slope (%)	N/A
N/A	Gutter Lip Ht (in)	N/A	N/A	Gutter X Slope (%)	N/A
N/A	Painted X Walk1?	Yes	N/A	Painted X Walk2?	No
	X Walk 1 Direction	To N		X Walk 2 Direction	To W
N/A	X Walk 1 Width (in)	70.0	N/A	X Walk 2 Width (in)	N/A
	X Walk 1 Slope (%)	1.8		X Walk 2 Slope (%)	6.5
	X Walk 1 X Slope (%)	4.8		X Walk 2 X Slope (%)	1.9

N/A	Ramp inside XWalk1?	Yes	N/A	Ramp inside XWalk2?	N/A
	Road Slope (%)	4.1	N/A	Clear Space?	N/A
	Road X Slope (%)	3.0	N/A	Clear Space to XWalk (in)	N/A
N/A	Any Obstructions?	N/A	N/A	Storm Grate/Utility Hazard?	N/A
	Obstruction Type			Storm Grate/Utility Type	
		N/A			N/A
		Yes		Surface Condition? (G/P)	Good

Remove & Replace Curb Ramp With Two New Directional Ramps or Equivalent.

Total Cost: \$ 3200.00
