# Access Compliance Report

## Public Rights-of-Way

### (Curb Ramps)

Intersection ID: 51510	Main Street: KENILWORTH_AV	Cross Street: PEARL_PARK_WY	Location: SE
ADA ID: 61C9FCAB27DB	Ramp Type: Perp	Initial Pass/Fail: Pass	Overall Compliance: No
Severity Score: 0			
Codes/Mitigation Info/Possible Solution		Field Measurements/Component Compliance

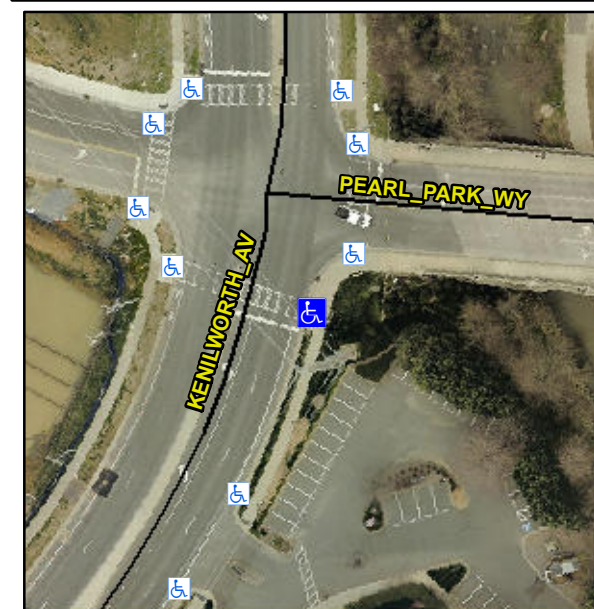
**Not Found, R304.2.1, R305.2**

Compliance	Description	Data	Compliance	Description	Data
N/A	Ramp Length (in)	48.0	Yes	Ramp Slope (%)	6.4
Yes	Ramp Width (in)	48.0	Yes	Ramp XSlope (%)	0.3
N/A	Flare Type LT	Sloped	N/A	Flare Type RT	N/A
N/A	Flare Slope LT (%)	3.2	Yes	Flare Slope RT (%)	5.6
N/A	Flare Traversable LT?	Yes	N/A	Flare Traversable RT?	Yes
No	Landing Length (in)	48.0	Yes	DWS Provided?	Yes
Yes	Landing Width (in)	48.0	Yes	DWS Contrast?	Yes
Yes	Landing Slope (%)	0.6	Yes	DWS Length (in)	24.0
Yes	Landing X Slope (%)	0.2	Yes	DWS Full Width?	Yes
N/A	Landing Curb? (Y/N)	Yes	No	DWS Offset (in)	3.0
N/A	Shared Landing?	No			
Yes	Gutter Ponding?	No	Yes	Gutter Slope (%)	1.0
Yes	Gutter Lip Ht (in)	0.0	Yes	Gutter X Slope (%)	1.0
N/A	Painted X Walk1?	Yes	N/A	Painted X Walk2?	N/A
	X Walk 1 Direction	To NW		X Walk 2 Direction	N/A
N/A	X Walk 1 Width (in)	111.0	N/A	X Walk 2 Width (in)	N/A
	X Walk 1 Slope (%)	3.0		X Walk 2 Slope (%)	N/A
	X Walk 1 X Slope (%)	0.5		X Walk 2 X Slope (%)	N/A

Yes	Ramp inside XWalk1?	Yes	N/A	Ramp inside XWalk2?	N/A
	Road Slope (%)	N/A	N/A	Clear Space?	Yes
	Road X Slope (%)	N/A	N/A	Clear Space to XWalk (in)	N/A
Yes	Any Obstructions?	No	Yes	Storm Grate/Utility Hazard?	No
	Obstruction Type			Storm Grate/Utility Type	
		N/A			N/A
			Yes	Surface Condition? (G/P)	Good

Possible Solutions:

**Remove & Replace Entire Ramp.**
