Access Compliance Report

Public Rights-of-Way

(Curb Ramps)

| Intersection ID: 15398 | Main Street: COLVILLE_RD | Cross Street: HEMPSTEAD_PL | Location: NW |

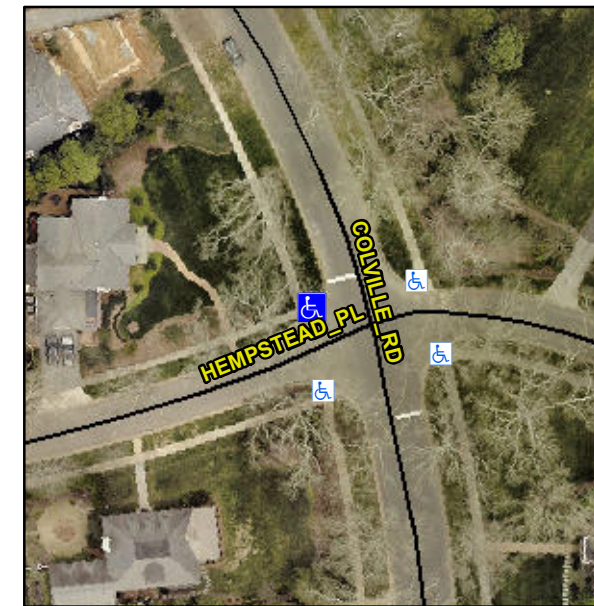
| ADA ID: 61D1DA6508D9 | Ramp Type: PerpDiag | Initial Pass/Fail: Fail | Overall Compliance: No |
| | | Severity Score: 12.5 | |

Not Found, R304.2.2

| Compliance | Description | Data | Compliance | Description | Data |
|---|---|---|---|---|---|
| N/A | Ramp Length (in) | 72.0 | No | Ramp Slope (%) | 9.0 |
| Yes | Ramp Width (in) | 48.0 | Yes | Ramp XSlope (%) | 0.2 |
| N/A | Gutter Ponding? | Yes | N/A | Gutter Slope (%) | N/A |

Remove & Replace Curb Ramp With Two New Directional Ramps or Equivalent.

Total Cost: \$ 3200.00
