Access Compliance Report

Public Rights-of-Way

(Curb Ramps)

Intersection ID: 3105	Main Street: DEARMON_RD	Cross Street: BROWNE_RD	Location: SE
ADA ID: 61D5455AA744	Ramp Type: Para	Initial Pass/Fail: Fail	Overall Compliance: No
Codes/Mitigation Info/Possible Solution		Field Measurements/Component Compliance

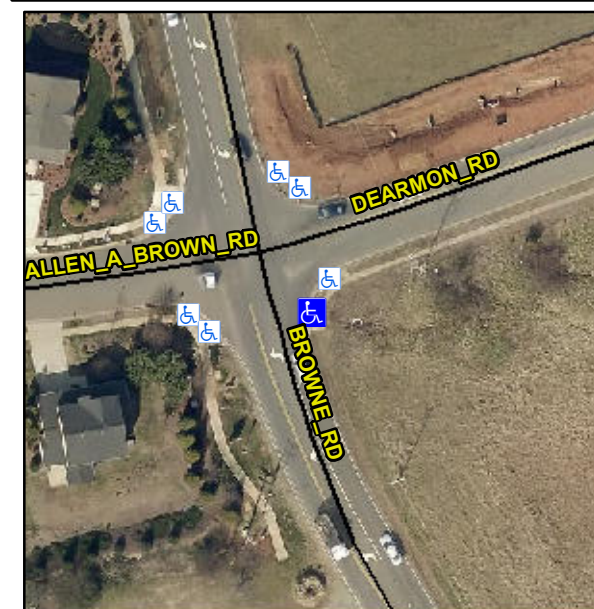
PROW/ADA:

R304.5.3, R304.3.2

Compliance	Description	Data	Compliance	Description	Data
N/A	Ramp Length LT (in)	42.0	N/A	Ramp Length RT (in)	46.5
Yes	Ramp Width LT (in)	48.0	Yes	Ramp Width RT (in)	49.0
Yes	Ramp Slope LT (%)	5.5	No	Ramp Slope RT (%)	8.5
No	Ramp XSlope LT (%)	2.5	Yes	Ramp XSlope RT (%)	0.4
N/A	Landing Length (in)	N/A	N/A	DWS Provided?	N/A
N/A	Landing Width (in)	N/A	N/A	DWS Contrast?	N/A
N/A	Landing Slope (%)	N/A	N/A	DWS Length (in)	N/A
N/A	Landing X Slope (%)	N/A	N/A	DWS Full Width?	N/A
N/A	Landing Curb? (Y/N)	N/A	N/A	DWS Offset (in)	N/A
N/A	Shared Landing?	N/A			
N/A	Gutter Ponding?	N/A	N/A	Gutter Slope (%)	N/A
N/A	Gutter Lip Ht (in)	N/A	N/A	Gutter X Slope (%)	N/A
N/A	Painted X Walk1?	Yes	N/A	Painted X Walk2?	N/A
	X Walk 1 Direction	To W		X Walk 2 Direction	N/A
N/A	X Walk 1 Width (in)	113.0	N/A	X Walk 2 Width (in)	N/A
	X Walk 1 Slope (%)	7.4		X Walk 2 Slope (%)	N/A
	X Walk 1 X Slope (%)	1.3		X Walk 2 X Slope (%)	N/A
N/A	Ramp inside XWalk1?	Yes	N/A	Ramp inside XWalk2?	N/A

Road Slope (%)	N/A	N/A	Clear Space?	N/A
	Road X Slope (%)	N/A	N/A	Clear Space to XWalk (in)	N/A
N/A	Any Obstructions?	N/A	N/A	Storm Grate/Utility Hazard?	N/A
	Obstruction Type			Storm Grate/Utility Type	
		N/A			N/A
			Yes	Surface Condition? (G/P)	Good
			N/A	Curb Slope (%)	N/A

Possible Solutions:

Remove & Replace Entire Ramp.
