Access Compliance Report

Public Rights-of-Way

(Curb Ramps)

| Intersection ID: 13152 | Main Street: SPRUCE_ST | Cross Street: W_KINGSTON_AV | Location: SW |

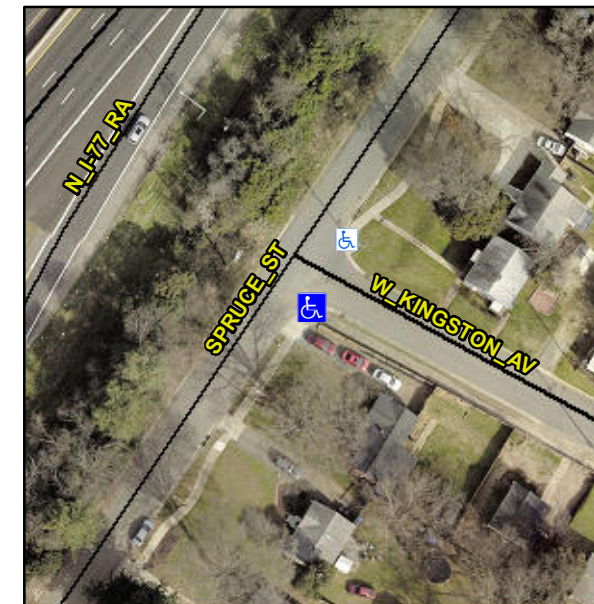
| ADA ID: 61D552C548D6 | Ramp Type: Combination1Diag | Initial Pass/Fail: Fail | Overall Compliance: No |

Not Found, R304.5.1, R304.5.3, R304.3.2

| Compliance | Description | Data | Compliance | Description | Data |
|---|---|---|---|---|---|
| No | Ramp Slope LT (%) | 12.5 | No | Ramp Slope RT (%) | 10.3 |
| No | Ramp Width (in) | 43.0 | No | Ramp XSlope (%) | 9.9 |

Remove & Replace Curb Ramp With Two New Directional Ramps or Equivalent.
