Access Compliance Report

Public Rights-of-Way

(Curb Ramps)

Intersection ID: 31185	Main Street: CARVER_POND_RD	Cross Street: CLOVERSIDE_LN	Location: SW
ADA ID: 61D5743AA0A3	Ramp Type: PerpDiag	Initial Pass/Fail: Fail	Overall Compliance: No
		Severity Score: 10

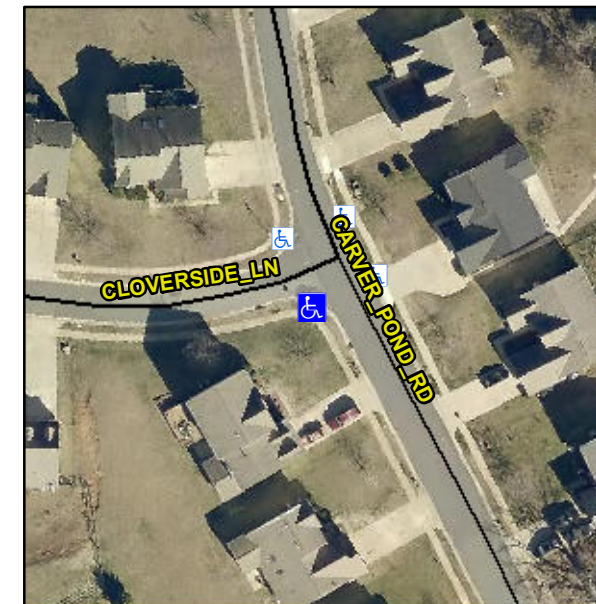
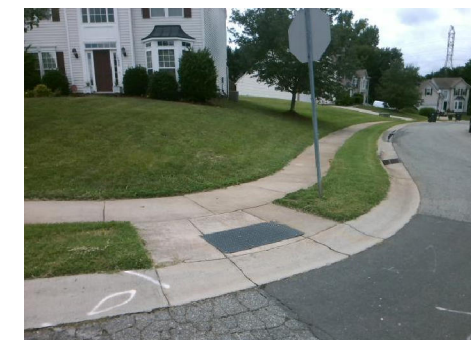
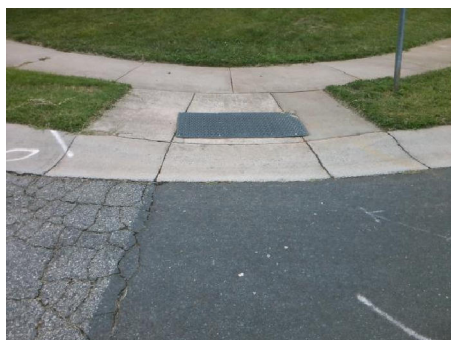
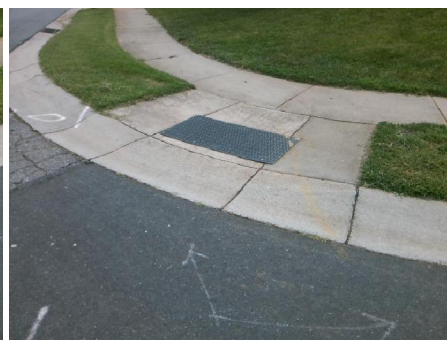
Not Found, R304.5.1, R304.5.3

Compliance	Description	Data	Compliance	Description	Data
N/A	Ramp Length (in)	54.0	Yes	Ramp Slope (%)	5.0
No	Ramp Width (in)	36.0	No	Ramp XSlope (%)	4.6
N/A	Flare Type LT	N/A	N/A	Flare Type RT	N/A
N/A	Flare Slope LT (%)	N/A	N/A	Flare Slope RT (%)	N/A
N/A	Flare Traversable LT?	N/A	N/A	Flare Traversable RT?	N/A
N/A	Landing Length (in)	N/A	N/A	DWS Provided?	N/A
N/A	Landing Width (in)	N/A	N/A	DWS Contrast?	N/A
N/A	Landing Slope (%)	N/A	N/A	DWS Length (in)	N/A
N/A	Landing X Slope (%)	N/A	N/A	DWS Full Width?	N/A
N/A	Landing Curb? (Y/N)	N/A	N/A	DWS Offset (in)	N/A
N/A	Shared Landing?	N/A			
N/A	Gutter Ponding?	N/A	N/A	Gutter Slope (%)	N/A
N/A	Gutter Lip Ht (in)	N/A	N/A	Gutter X Slope (%)	N/A
N/A	Painted X Walk1?	No	N/A	Painted X Walk2?	No
	X Walk 1 Direction	To E		X Walk 2 Direction	To N
N/A	X Walk 1 Width (in)	N/A	N/A	X Walk 2 Width (in)	N/A
	X Walk 1 Slope (%)	4.4		X Walk 2 Slope (%)	3.6
	X Walk 1 X Slope (%)	7.1		X Walk 2 X Slope (%)	0.7

N/A	Ramp inside XWalk1?	N/A	N/A	Ramp inside XWalk2?	N/A
	Road Slope (%)	6.7	N/A	Clear Space?	N/A
	Road X Slope (%)	3.3	N/A	Clear Space to XWalk (in)	N/A
N/A	Any Obstructions?	N/A	N/A	Storm Grate/Utility Hazard?	N/A
	Obstruction Type			Storm Grate/Utility Type	
		N/A			N/A
			Yes	Surface Condition? (G/P)	Good

Remove & Replace Curb Ramp With Two New Directional Ramps or Equivalent.
