Access Compliance Report

Public Rights-of-Way

(Curb Ramps)

Intersection ID: 3591	Main Street: CHAPEL RIDGE RD	Cross Street: SPRING LEE CT	Location: SE
ADA ID: 61DD06DB088C	Ramp Type: Perp	Initial Pass/Fail: Fail	Overall Compliance: No
Severity Score: 46.25			
Codes/Mitigation Info/Possible Solution		Field Measurements/Component Compliance

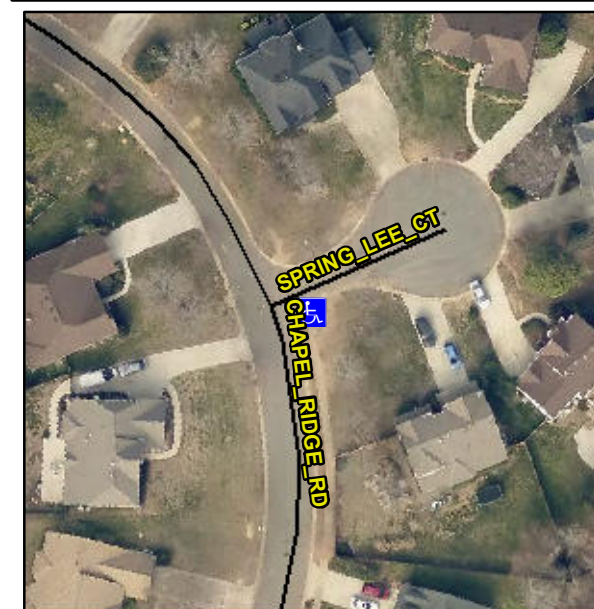
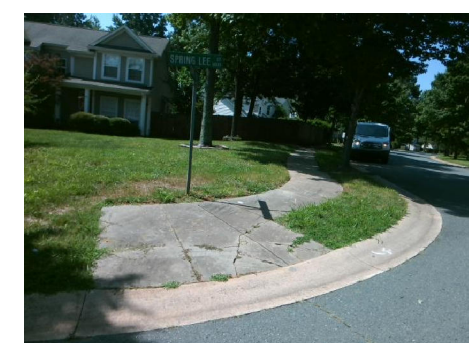
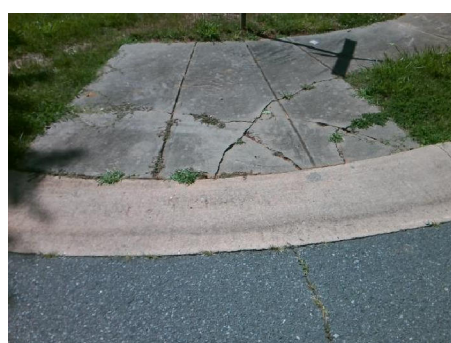
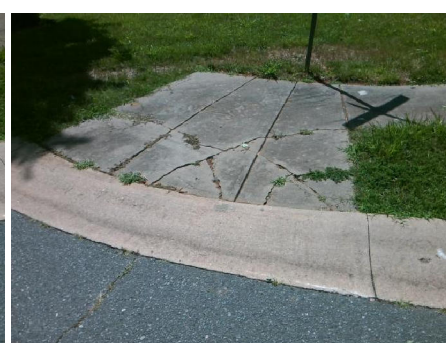
Not Found, R304.5.1, R304.2.2, R304.5.3, R302.7

Compliance	Description	Data	Compliance	Description	Data
N/A	Ramp Length (in)	52.0	No	Ramp Slope (%)	8.5
No	Ramp Width (in)	32.0	No	Ramp XSlope (%)	4.5
N/A	Flare Type LT	N/A	N/A	Flare Type RT	N/A
N/A	Flare Slope LT (%)	N/A	N/A	Flare Slope RT (%)	N/A
N/A	Flare Traversable LT?	N/A	N/A	Flare Traversable RT?	N/A
N/A	Landing Length (in)	N/A	N/A	DWS Provided?	N/A
N/A	Landing Width (in)	N/A	N/A	DWS Contrast?	N/A
N/A	Landing Slope (%)	N/A	N/A	DWS Length (in)	N/A
N/A	Landing X Slope (%)	N/A	N/A	DWS Full Width?	N/A
N/A	Landing Curb? (Y/N)	N/A	N/A	DWS Offset (in)	N/A
N/A	Shared Landing?	N/A			
N/A	Gutter Ponding?	N/A	N/A	Gutter Slope (%)	N/A
N/A	Gutter Lip Ht (in)	N/A	N/A	Gutter X Slope (%)	N/A
N/A	Painted X Walk1?	No	N/A	Painted X Walk2?	N/A
	X Walk 1 Direction	To N		X Walk 2 Direction	N/A
N/A	X Walk 1 Width (in)	N/A	N/A	X Walk 2 Width (in)	N/A
	X Walk 1 Slope (%)	1.1		X Walk 2 Slope (%)	N/A
	X Walk 1 X Slope (%)	5.1		X Walk 2 X Slope (%)	N/A

N/A	Ramp inside XWalk1?	N/A	N/A	Ramp inside XWalk2?	N/A
	Road Slope (%)	N/A	N/A	Clear Space?	N/A
	Road X Slope (%)	N/A	N/A	Clear Space to XWalk (in)	N/A
N/A	Any Obstructions?	N/A	N/A	Storm Grate/Utility Hazard?	N/A
	Obstruction Type			Storm Grate/Utility Type	
		N/A			N/A
		No		Surface Condition? (G/P)	Poor

Possible Solutions:

Remove & Replace Entire Ramp.
