# Access Compliance Report

## Public Rights-of-Way

### (Curb Ramps)

| Intersection ID: 43846 | Main Street: CURRIER_RD | Cross Street: BRADSTREET_COMMONS_WY | Location: NE |

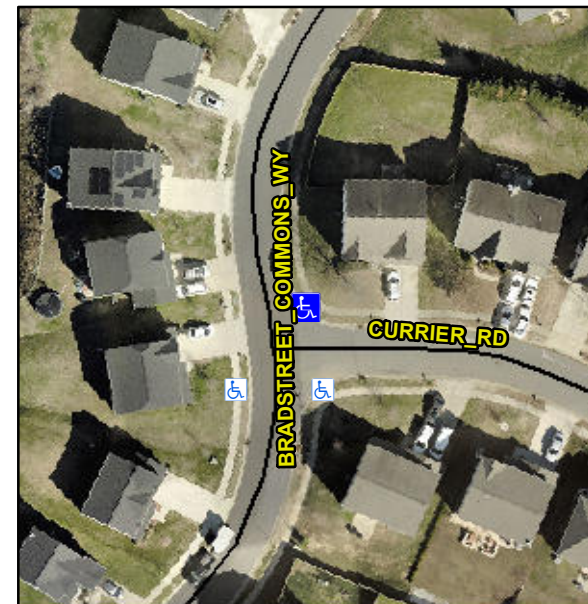
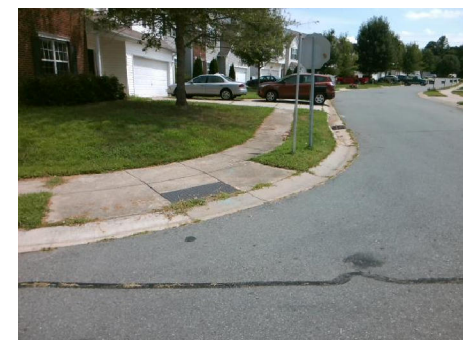
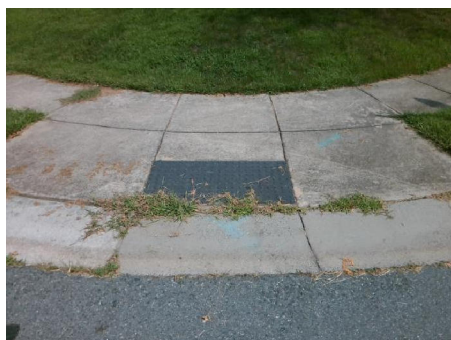
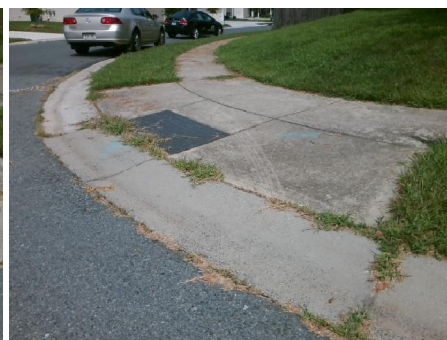
**Not Found, R304.5.1, R304.2.2, R304.5.3**

| Compliance | Description | Data | Compliance | Description | Data |
|---|---|---|---|---|---|
| N/A | Ramp Length (in) | 48.0 | No | Ramp Slope (%) | 9.8 |
| No | Ramp Width (in) | 47.0 | No | Ramp XSlope (%) | 3.4 |

**Remove & Replace Curb Ramp With Two New Directional Ramps or Equivalent.**
