Access Compliance Report

Public Rights-of-Way

(Curb Ramps)

| Intersection ID: 10025310 | Main Street: E_5TH_ST | Cross Street: N/A | Location: SE |

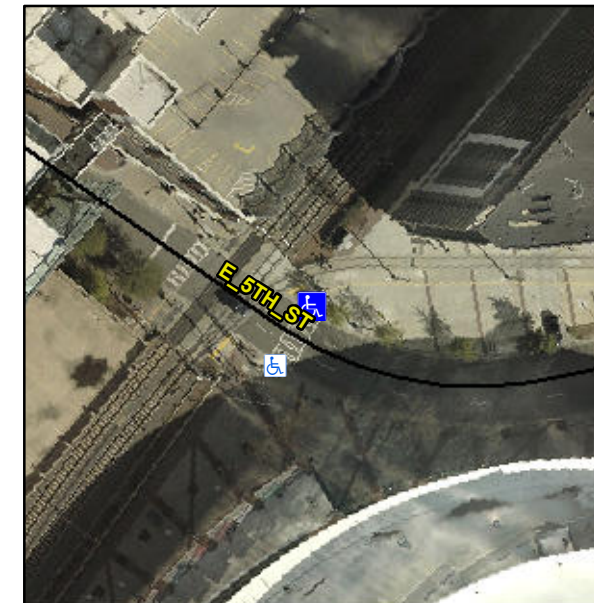
| ADA ID: 61E5FFBD6A58 | Ramp Type: Perp | Initial Pass/Fail: Pass | Overall Compliance: No |

| Compliance | Description | Data | Compliance | Description | Data |
|---|---|---|---|---|---|
| No | Landing Slope (%) | 2.3 | Yes | DWS Length (in) | 24.0 |

Remove & Replace Landing.

R304.2.2-Perp, R304.3.2-Para
