# Access Compliance Report

## Public Rights-of-Way

### (Curb Ramps)

| Intersection ID: 26209 | Main Street: CARMEL_RD | Cross Street: JOHNSTON_RD | Location: N |

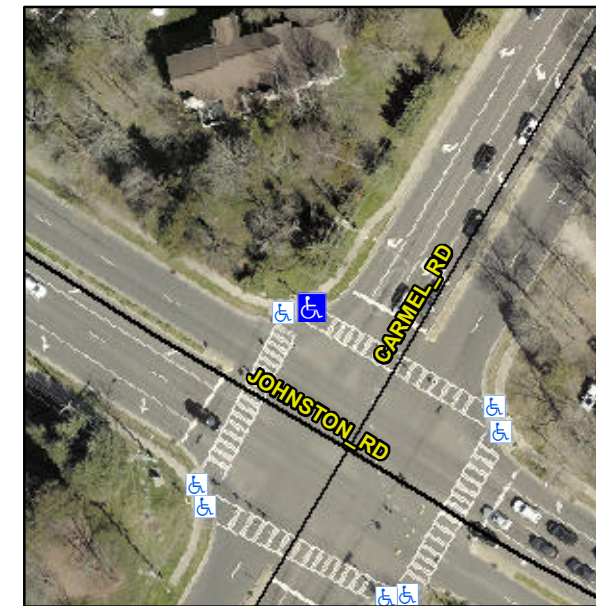
| ADA ID: 61EAE55BE767 | Ramp Type: Perp | Initial Pass/Fail: Fail | Overall Compliance: No |
| Severity Score: 46.25 | | | |

**R304.5.1, R304.2.2, R304.5.3**

| Compliance | Description | Data | Compliance | Description | Data |
|---|---|---|---|---|---|
| N/A | Ramp Length (in) | 59.0 | No | Ramp Slope (%) | 8.5 |
| No | Ramp Width (in) | 43.5 | No | Ramp XSlope (%) | 7.0 |

**Remove & Replace Entire Ramp.**

Total Cost: \$ 1850.00
