Access Compliance Report

Public Rights-of-Way

(Curb Ramps)

Intersection ID: 42579	Main Street: GERALDINE_POWE_DR	Cross Street: STROUD_PARK_CT	Location: NE
ADA ID: 6204C8B74362	Ramp Type: BlendTrans1	Initial Pass/Fail: Fail	Overall Compliance: No
Severity Score: 10			
Codes/Mitigation Info/Possible Solution		Field Measurements/Component Compliance

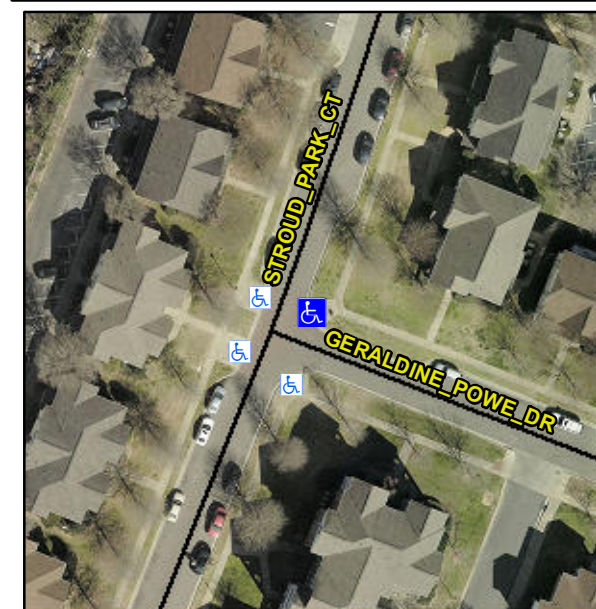
Compliance	Description	Data	Compliance	Description	Data
N/A	Ramp Length (in)	138.5	Yes	BlendTrans Slope (%)	4.5
No	Ramp Width (in)	45.0	No	BlendTrans XSlope (%)	4.7
N/A	Flare Type LT	N/A	N/A	Flare Type RT	N/A
N/A	Flare Slope LT (%)	N/A	N/A	Flare Slope RT (%)	N/A
N/A	Flare Traversable LT?	N/A	N/A	Flare Traversable RT?	N/A
N/A	Landing Length (in)	N/A	N/A	DWS Provided?	N/A
N/A	Landing Width (in)	N/A	N/A	DWS Contrast?	N/A
N/A	Landing Slope (%)	N/A	N/A	DWS Length (in)	N/A
N/A	Landing X Slope (%)	N/A	N/A	DWS Full Width?	N/A
N/A	Landing Curb? (Y/N)	N/A	N/A	DWS Offset (in)	N/A
N/A	Shared Landing?	N/A			
N/A	Gutter Ponding?	N/A	N/A	Gutter Slope (%)	N/A
N/A	Gutter Lip Ht (in)	N/A	N/A	Gutter X Slope (%)	N/A
N/A	Painted X Walk1?	No	N/A	Painted X Walk2?	No
	X Walk 1 Direction	To W		X Walk 2 Direction	To S
	X Walk 1 Width (in)	N/A		X Walk 2 Width (in)	N/A
	X Walk 1 Slope (%)	1.0		X Walk 2 Slope (%)	2.5
	X Walk 1 X Slope (%)	3.0		X Walk 2 X Slope (%)	0.2

N/A	Ramp inside XWalk1?	N/A	N/A	Ramp inside XWalk2?	N/A
	Road Slope (%)	2.1		Clear Space?	N/A
	Road X Slope (%)	2.5	N/A	Clear Space to XWalk (in)	N/A
N/A	Any Obstructions?	N/A	N/A	Storm Grate/Utility Hazard?	N/A
	Obstruction Type			Storm Grate/Utility Type	
		N/A			N/A
			Yes	Surface Condition? (G/P)	Good
			N/A	Curb Slope (%)	N/A

Possible Solutions:

Remove & Replace Curb Ramp With Two New Directional Ramps or Equivalent.

R304.5.1, R304.5.3

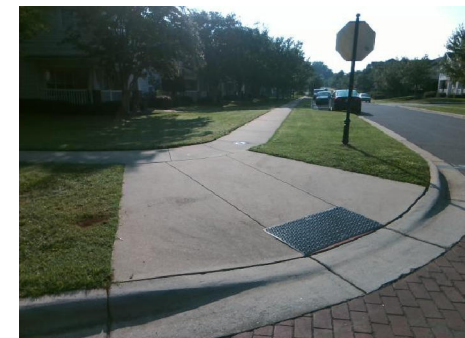
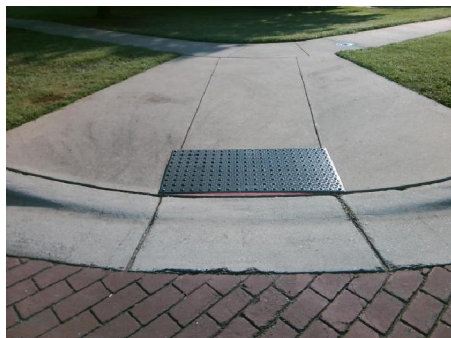
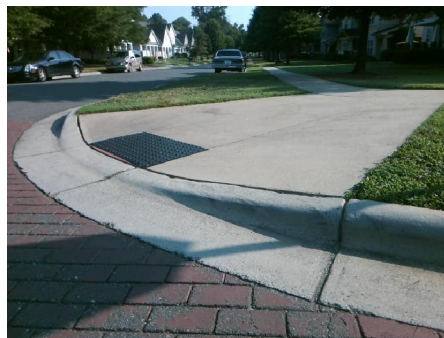
Street 1 Name **STROUD PARK CT**
 Stop Condition-Street 1 **None**
 Street 2 Name **GERALDINE POWE DR**
 Stop Condition-Street 2 **StopSign**
