Access Compliance Report

Public Rights-of-Way

(Curb Ramps)

Intersection ID: 5224	Main Street: FROSTMOOR_PL	Cross Street: GROVETON_CT	Location: NE
ADA ID: 6205063BB756	Ramp Type: Perp	Initial Pass/Fail: Fail	Overall Compliance: No
Severity Score: 25			
Codes/Mitigation Info/Possible Solution		Field Measurements/Component Compliance

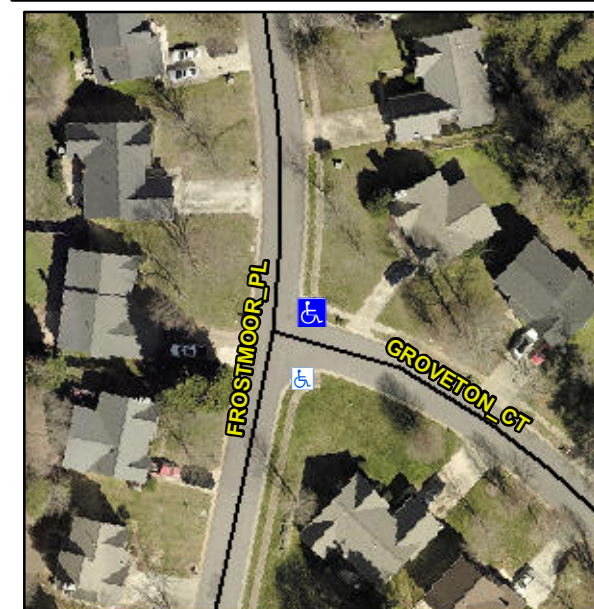
Not Found, R304.2.2

Compliance	Description	Data	Compliance	Description	Data
N/A	Ramp Length (in)	48.0	No	Ramp Slope (%)	20.0
Yes	Ramp Width (in)	48.0	Yes	Ramp XSlope (%)	0.2
N/A	Flare Type LT	N/A	N/A	Flare Type RT	N/A
N/A	Flare Slope LT (%)	N/A	N/A	Flare Slope RT (%)	N/A
N/A	Flare Traversable LT?	N/A	N/A	Flare Traversable RT?	N/A
N/A	Landing Length (in)	N/A	N/A	DWS Provided?	N/A
N/A	Landing Width (in)	N/A	N/A	DWS Contrast?	N/A
N/A	Landing Slope (%)	N/A	N/A	DWS Length (in)	N/A
N/A	Landing X Slope (%)	N/A	N/A	DWS Full Width?	N/A
N/A	Landing Curb? (Y/N)	N/A	N/A	DWS Offset (in)	N/A
N/A	Shared Landing?	N/A			
N/A	Gutter Ponding?	N/A	N/A	Gutter Slope (%)	N/A
N/A	Gutter Lip Ht (in)	N/A	N/A	Gutter X Slope (%)	N/A
N/A	Painted X Walk1?	No	N/A	Painted X Walk2?	N/A
	X Walk 1 Direction	To S		X Walk 2 Direction	N/A
N/A	X Walk 1 Width (in)	N/A	N/A	X Walk 2 Width (in)	N/A
	X Walk 1 Slope (%)	5.4		X Walk 2 Slope (%)	N/A
	X Walk 1 X Slope (%)	4.1		X Walk 2 X Slope (%)	N/A

N/A	Ramp inside XWalk1?	N/A	N/A	Ramp inside XWalk2?	N/A
	Road Slope (%)	N/A	N/A	Clear Space?	N/A
	Road X Slope (%)	N/A	N/A	Clear Space to XWalk (in)	N/A
N/A	Any Obstructions?	N/A	N/A	Storm Grate/Utility Hazard?	N/A
	Obstruction Type			Storm Grate/Utility Type	
		N/A			N/A
			Yes	Surface Condition? (G/P)	Good

Remove & Replace Entire Ramp.
