# Access Compliance Report

## Public Rights-of-Way

### (Curb Ramps)

| Intersection ID: 54465 | Main Street: RUPELL_DR | Cross Street: COLLINGHAM_DR | Location: NE |

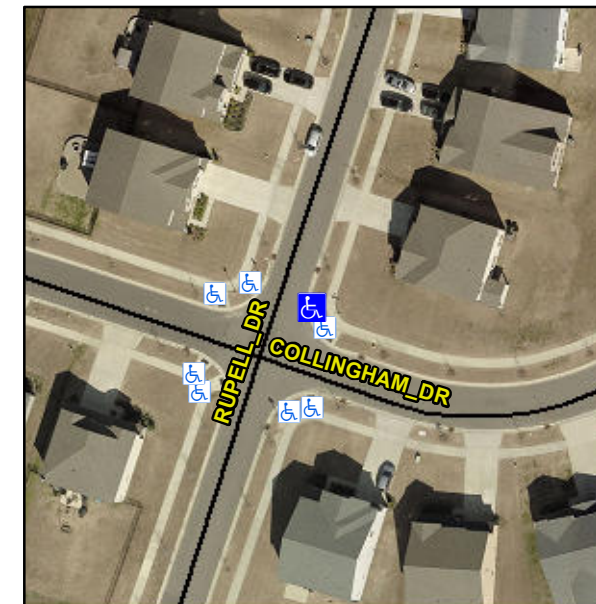
| ADA ID: 620FFB5E58D0 | Ramp Type: BlendTrans1 | Initial Pass/Fail: Fail | Overall Compliance: No |
| | | Severity Score: 10 | |

**Not Found, R304.5.1, R304.5.3**

| Compliance | Description | Data | Compliance | Description | Data |
|---|---|---|---|---|---|
| No | Ramp Width (in) | 45.5 | No | BlendTrans XSlope (%) | 3.5 |
| | | | No | Curb Slope (%) | 15.9 |

**Remove & Replace Curb Ramp With Two New Directional Ramps or Equivalent.**
