# Access Compliance Report

## Public Rights-of-Way

### (Curb Ramps)

Intersection ID: 25898	Main Street: BLUE_HERON_DR	Cross Street: CASTLEKEEP_RD	Location: NE
ADA ID: 6238F2DB2294	Ramp Type: PerpDiag	Initial Pass/Fail: Fail	Overall Compliance: No
			Severity Score: 21.25

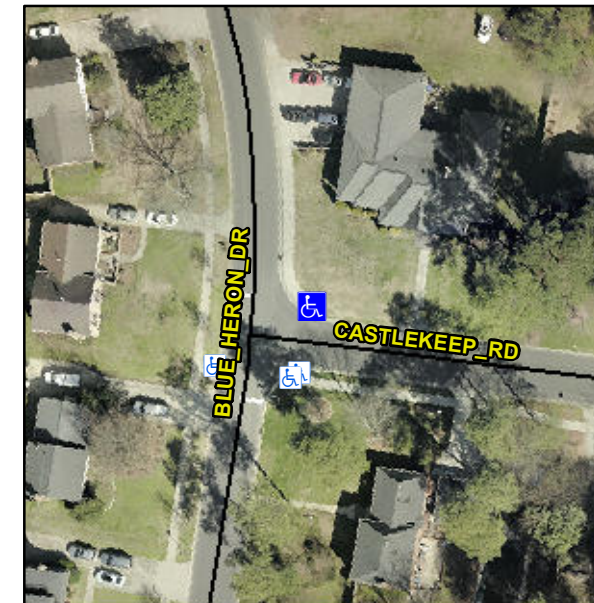
**Not Found, R304.5.1, R304.5.3**

Compliance	Description	Data	Compliance	Description	Data
N/A	Ramp Length (in)	71.0	Yes	Ramp Slope (%)	5.7
No	Ramp Width (in)	47.5	No	Ramp XSlope (%)	5.4
N/A	Flare Type LT	N/A	N/A	Flare Type RT	N/A
N/A	Flare Slope LT (%)	N/A	N/A	Flare Slope RT (%)	N/A
N/A	Flare Traversable LT?	N/A	N/A	Flare Traversable RT?	N/A
N/A	Landing Length (in)	N/A	N/A	DWS Provided?	N/A
N/A	Landing Width (in)	N/A	N/A	DWS Contrast?	N/A
N/A	Landing Slope (%)	N/A	N/A	DWS Length (in)	N/A
N/A	Landing X Slope (%)	N/A	N/A	DWS Full Width?	N/A
N/A	Landing Curb? (Y/N)	N/A	N/A	DWS Offset (in)	N/A
N/A	Shared Landing?	N/A			
N/A	Gutter Ponding?	N/A	N/A	Gutter Slope (%)	N/A
N/A	Gutter Lip Ht (in)	N/A	N/A	Gutter X Slope (%)	N/A
N/A	Painted X Walk1?	No	N/A	Painted X Walk2?	No
	X Walk 1 Direction	To W		X Walk 2 Direction	To S
N/A	X Walk 1 Width (in)	N/A	N/A	X Walk 2 Width (in)	N/A
	X Walk 1 Slope (%)	2.7		X Walk 2 Slope (%)	2.6
	X Walk 1 X Slope (%)	0.2		X Walk 2 X Slope (%)	1.7

N/A	Ramp inside XWalk1?	N/A	N/A	Ramp inside XWalk2?	N/A
	Road Slope (%)	1.4	N/A	Clear Space?	N/A
	Road X Slope (%)	4.9	N/A	Clear Space to XWalk (in)	N/A
N/A	Any Obstructions?	N/A	N/A	Storm Grate/Utility Hazard?	N/A
	Obstruction Type			Storm Grate/Utility Type	
		N/A			N/A
			Yes	Surface Condition? (G/P)	Good

**Remove & Replace Curb Ramp With Two New Directional Ramps or Equivalent.**
