Access Compliance Report Public Rights-of-Way (Curb Ramps)

Intersection ID: 10040110Main Street: TUCKASEGEE_RDCross Street: N/ALocation:NADA ID: 6245687ADCEDRamp Type: PerpInitial Pass/Fail: FailOverall Compliance: NoSeverity Score: 21.25

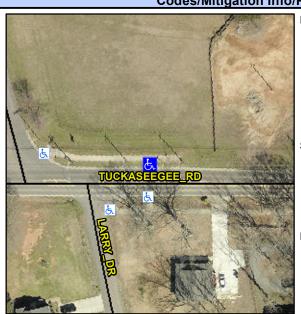
Comp	liance Description	Data	Comp	liance	Description	Data
N/A	Ramp Length (in)	71.0	No	Ramp	Slope (%)	8.6
No	Ramp Width (in)	47.0	Yes	Ramp	XSlope (%)	0.4
N/A	Flare Type LT	N/A	N/A	Flare	Type RT	N/A
N/A	Flare Slope LT (%)	N/A	N/A	Flare	Slope RT (%)	N/A
N/A	Flare Traversable LT?	N/A	N/A	Flare	Traversable RT?	N/A
N/A	Landing Length (in)	N/A	N/A	DWS	Provided?	N/A
N/A	Landing Width (in)	N/A	N/A	DWS	Contrast?	N/A
N/A	Landing Slope (%)	N/A	N/A	DWS	Length (in)	N/A
N/A	Landing X Slope (%)	N/A	N/A	DWS	Full Width?	N/A
N/A	Landing Curb? (Y/N)	N/A	N/A	DWS	Offset (in)	N/A
N/A	Shared Landing?	N/A				
N/A	Gutter Ponding?	Yes	N/A	Gutte	r Slope (%)	N/A
N/A	Gutter Lip Ht (in)	N/A	N/A	Gutte	r X Slope (%)	N/A
N/A	Painted X Walk1?	No	N/A	Paint	ed X Walk2?	N/A
	X Walk 1 Direction	To S		X Wa	lk 2 Direction	N/A
N/A	X Walk 1 Width (in)	N/A	N/A	X Wa	lk 2 Width (in)	N/A
	X Walk 1 Slope (%)	2.8		X Wa	lk 2 Slope (%)	N/A
	X Walk 1 X Slope (%)	0.3		X Wa	lk 2 X Slope (%)	N/A

N/A	Ramp inside XWalk1?	N/A	N/A	Ramp	inside XWalk2?	N/A
	Road Slope (%)	N/A	N/A	Clear	Space?	N/A
	Road X Slope (%)	N/A	N/A	Clear	Space to XWalk (in)	N/A
N/A	Any Obstructions?	N/A	N/A	Storm	Grate/Utility Hazard?	N/A
	Obstruction Type			Storm	Grate/Utility Type	
	••	N/A				N/A
			Yes	Surfa	ce Condition? (G/P)	Good

Possible Solutions:	
Remove & Replace Entire Ramp.	ı
	I
	1
Surveyor Notes:	i
N/A	ı
	I
	I
	ı
PROW/ADA:	I
Not Found, R304.5.1, R304.2.2	!
	ı
	ı
	,

1850.00
