Access Compliance Report

Public Rights-of-Way

(Curb Ramps)

Intersection ID: 12347	Main Street: S_CHURCH_ST	Cross Street: W_3RD_ST	Location: W
ADA ID: 624DE83349B9	Ramp Type: BlendTrans1	Initial Pass/Fail: Fail	Overall Compliance: No
		Severity Score: 12.5

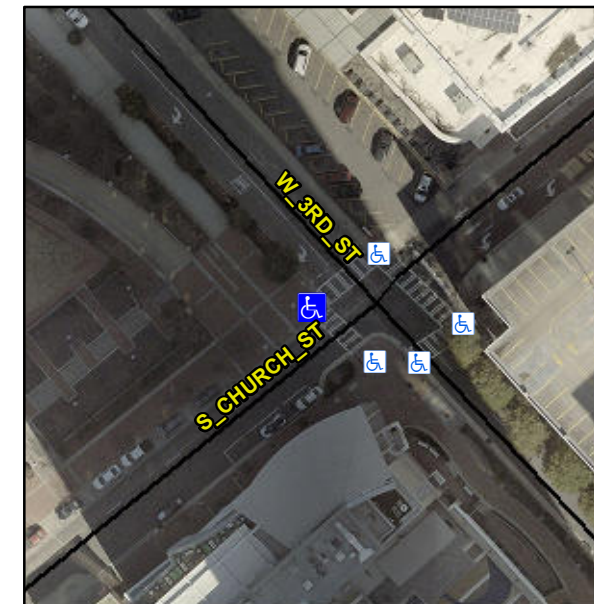
Compliance	Description	Data	Compliance	Description	Data
N/A	Ramp Length (in)	64.0	Yes	BlendTrans Slope (%)	3.4
Yes	Ramp Width (in)	115.0	No	BlendTrans XSlope (%)	6.9
N/A	Flare Type LT	N/A	N/A	Flare Type RT	N/A
N/A	Flare Slope LT (%)	N/A	N/A	Flare Slope RT (%)	N/A
N/A	Flare Traversable LT?	N/A	N/A	Flare Traversable RT?	N/A
N/A	Landing Length (in)	N/A	N/A	DWS Provided?	N/A
N/A	Landing Width (in)	N/A	N/A	DWS Contrast?	N/A
N/A	Landing Slope (%)	N/A	N/A	DWS Length (in)	N/A
N/A	Landing X Slope (%)	N/A	N/A	DWS Full Width?	N/A
N/A	Landing Curb? (Y/N)	N/A	N/A	DWS Offset (in)	N/A
N/A	Shared Landing?	N/A			
N/A	Gutter Ponding?	N/A	N/A	Gutter Slope (%)	N/A
N/A	Gutter Lip Ht (in)	N/A	N/A	Gutter X Slope (%)	N/A
N/A	Painted X Walk1?	Yes	N/A	Painted X Walk2?	Yes
	X Walk 1 Direction	To SE		X Walk 2 Direction	To NE
	X Walk 1 Width (in)	104.0		X Walk 2 Width (in)	111.0
	X Walk 1 Slope (%)	8.4		X Walk 2 Slope (%)	4.6
	X Walk 1 X Slope (%)	2.4		X Walk 2 X Slope (%)	11.3

N/A	Ramp inside XWalk1?	Yes	N/A	Ramp inside XWalk2?	Yes
	Road Slope (%)	2.9		Clear Space?	N/A
	Road X Slope (%)	9.4	N/A	Clear Space to XWalk (in)	N/A
N/A	Any Obstructions?	N/A	N/A	Storm Grate/Utility Hazard?	N/A
	Obstruction Type			Storm Grate/Utility Type	
		N/A			N/A
			Yes	Surface Condition? (G/P)	Good
			N/A	Curb Slope (%)	0.3

Possible Solutions:

Remove & Replace Curb Ramp With Two New Directional Ramps or Equivalent.

R304.5.3

Total Cost: \$ 3200.00
