Access Compliance Report

Public Rights-of-Way (Curb Ramps)

Intersection ID: 50591	Main Street: GREEN_GRASS_RD	Cross Street: LONGSTRAW_RD	Location: NW
ADA ID: 624E2B9D74AF	Ramp Type: Perp	Initial Pass/Fail: Fail	Overall Compliance: No
		Severity Score: 12.5

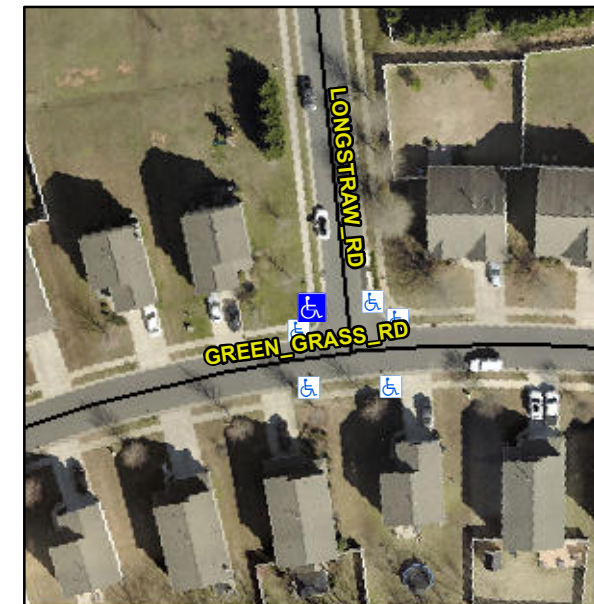
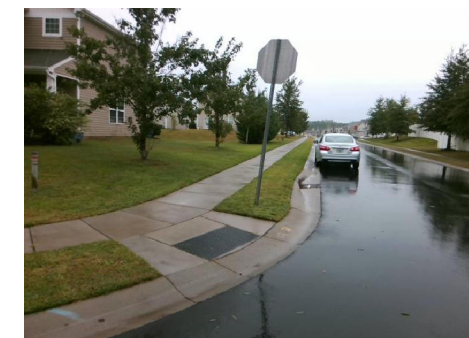
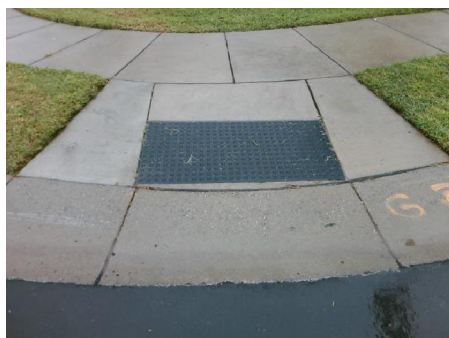
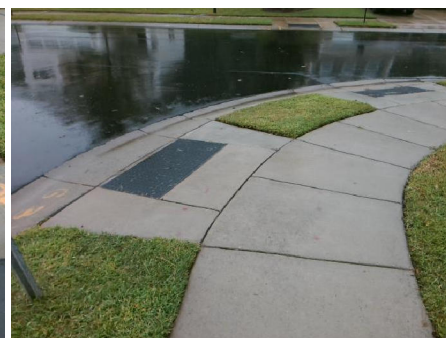
Compliance	Description	Data	Compliance	Description	Data
N/A	Ramp Length (in)	48.0	No	Ramp Slope (%)	9.0
Yes	Ramp Width (in)	48.0	Yes	Ramp XSlope (%)	1.3
N/A	Flare Type LT	N/A	N/A	Flare Type RT	N/A
N/A	Flare Slope LT (%)	N/A	N/A	Flare Slope RT (%)	N/A
N/A	Flare Traversable LT?	N/A	N/A	Flare Traversable RT?	N/A
N/A	Landing Length (in)	N/A	N/A	DWS Provided?	N/A
N/A	Landing Width (in)	N/A	N/A	DWS Contrast?	N/A
N/A	Landing Slope (%)	N/A	N/A	DWS Length (in)	N/A
N/A	Landing X Slope (%)	N/A	N/A	DWS Full Width?	N/A
N/A	Landing Curb? (Y/N)	N/A	N/A	DWS Offset (in)	N/A
N/A	Shared Landing?	N/A			
N/A	Gutter Ponding?	N/A	N/A	Gutter Slope (%)	N/A
N/A	Gutter Lip Ht (in)	N/A	N/A	Gutter X Slope (%)	N/A
N/A	Painted X Walk1?	No	N/A	Painted X Walk2?	N/A
	X Walk 1 Direction	To E		X Walk 2 Direction	N/A
N/A	X Walk 1 Width (in)	N/A	N/A	X Walk 2 Width (in)	N/A
	X Walk 1 Slope (%)	3.3		X Walk 2 Slope (%)	N/A
	X Walk 1 X Slope (%)	0.9		X Walk 2 X Slope (%)	N/A

N/A	Ramp inside XWalk1?	N/A	N/A	Ramp inside XWalk2?	N/A
	Road Slope (%)	N/A	N/A	Clear Space?	N/A
	Road X Slope (%)	N/A	N/A	Clear Space to XWalk (in)	N/A
N/A	Any Obstructions?	N/A	N/A	Storm Grate/Utility Hazard?	N/A
	Obstruction Type			Storm Grate/Utility Type	
		N/A			N/A
			Yes	Surface Condition? (G/P)	Good

Remove & Replace Entire Ramp.

R304.2.2

\$ 1850.00
