# Access Compliance Report

## Public Rights-of-Way

### (Curb Ramps)

Intersection ID: 28118	Main Street: DARBY_CHASE_DR	Cross Street: KENSWORTH_CT	Location: SE
ADA ID: 62575CAF2E27	Ramp Type: Perp	Initial Pass/Fail: Fail	Overall Compliance: No
Severity Score: 8.75			
Codes/Mitigation Info/Possible Solution		Field Measurements/Component Compliance

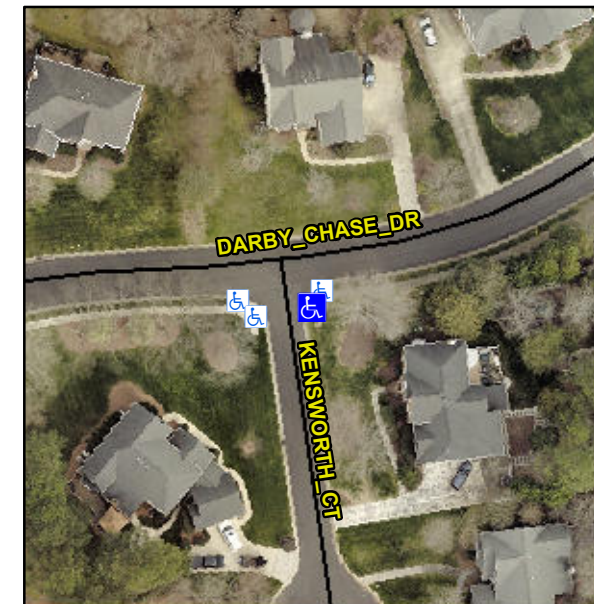
**Not Found, R304.5.1**

Compliance	Description	Data	Compliance	Description	Data
N/A	Ramp Length (in)	47.5	Yes	Ramp Slope (%)	6.2
No	Ramp Width (in)	42.0	Yes	Ramp XSlope (%)	1.8
N/A	Flare Type LT	N/A	N/A	Flare Type RT	N/A
N/A	Flare Slope LT (%)	N/A	N/A	Flare Slope RT (%)	N/A
N/A	Flare Traversable LT?	N/A	N/A	Flare Traversable RT?	N/A
N/A	Landing Length (in)	N/A	N/A	DWS Provided?	N/A
N/A	Landing Width (in)	N/A	N/A	DWS Contrast?	N/A
N/A	Landing Slope (%)	N/A	N/A	DWS Length (in)	N/A
N/A	Landing X Slope (%)	N/A	N/A	DWS Full Width?	N/A
N/A	Landing Curb? (Y/N)	N/A	N/A	DWS Offset (in)	N/A
N/A	Shared Landing?	N/A			
N/A	Gutter Ponding?	N/A	N/A	Gutter Slope (%)	N/A
N/A	Gutter Lip Ht (in)	N/A	N/A	Gutter X Slope (%)	N/A
N/A	Painted X Walk1?	No	N/A	Painted X Walk2?	N/A
	X Walk 1 Direction	To W		X Walk 2 Direction	N/A
N/A	X Walk 1 Width (in)	N/A	N/A	X Walk 2 Width (in)	N/A
	X Walk 1 Slope (%)	1.4		X Walk 2 Slope (%)	N/A
	X Walk 1 X Slope (%)	0.4		X Walk 2 X Slope (%)	N/A

N/A	Ramp inside XWalk1?	N/A	N/A	Ramp inside XWalk2?	N/A
	Road Slope (%)	N/A	N/A	Clear Space?	N/A
	Road X Slope (%)	N/A	N/A	Clear Space to XWalk (in)	N/A
N/A	Any Obstructions?	N/A	N/A	Storm Grate/Utility Hazard?	N/A
	Obstruction Type			Storm Grate/Utility Type	
		N/A			N/A
			Yes	Surface Condition? (G/P)	Good

**Remove & Replace Entire Ramp.**
