Access Compliance Report

Public Rights-of-Way

(Curb Ramps)

Intersection ID: 49789	Main Street: BARLEY_LN	Cross Street: GRASS_DR	Location: E
ADA ID: 62580CDE1A41	Ramp Type: Perp	Initial Pass/Fail: Fail	Overall Compliance: No
			Severity Score: 13.75

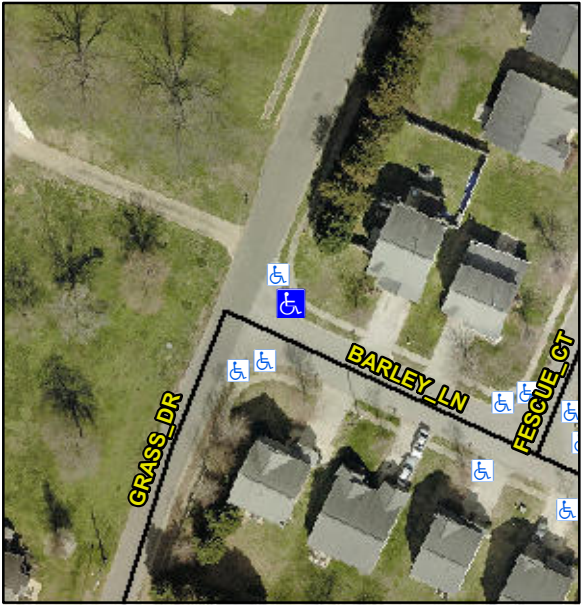
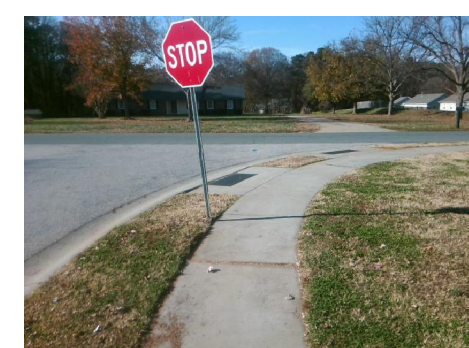
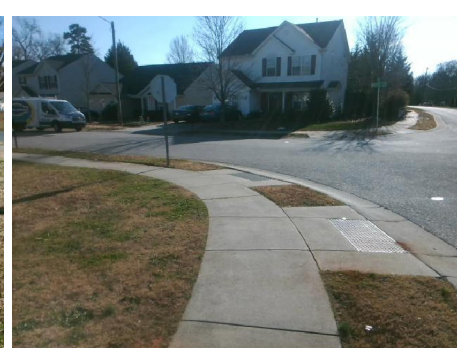
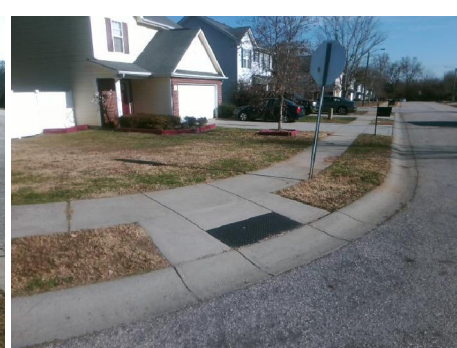
Possible Solutions:		Compliance	Description	Data
	Remove & Replace Entire Ramp.		No	Ramp Length (in)	48.0
			Yes	Ramp Width (in)	48.0
			N/A	Flare Type LT	N/A
			N/A	Flare Slope LT (%)	N/A
			N/A	Flare Traversable LT?	N/A
			N/A	Landing Length (in)	N/A
			N/A	Landing Width (in)	N/A
			N/A	Landing Slope (%)	N/A
			N/A	Landing X Slope (%)	N/A
<p>Surveyor Notes:</p> <p>N/A</p> <p>PROW/ADA:</p> <p>Not Found, R304.2.2, R304.5.3</p>			N/A	Flare Type RT	N/A
			N/A	Flare Slope RT (%)	N/A
			N/A	Flare Traversable RT?	N/A
			N/A	DWS Provided?	N/A
			N/A	DWS Contrast?	N/A
			N/A	DWS Length (in)	N/A
			N/A	DWS Full Width?	N/A
			N/A	DWS Offset (in)	N/A
			N/A	Gutter Ponding?	N/A
			N/A	Gutter Lip Ht (in)	N/A
			No	Painted X Walk1?	N/A
			To SW	X Walk 1 Direction	N/A
			N/A	X Walk 1 Width (in)	N/A

1.5	X Walk 1 Slope (%)	N/A
			2.8	X Walk 1 X Slope (%)	N/A
			N/A	Ramp inside XWalk1?	N/A
			N/A	Road Slope (%)	N/A
			N/A	Road X Slope (%)	N/A
			N/A	Any Obstructions?	N/A
			N/A	Obstruction Type	N/A
Total Cost:			\$	1850.00	
			N/A		N/A
			Yes	Surface Condition? (G/P)	Good
