# Access Compliance Report

## Public Rights-of-Way

### (Curb Ramps)

Intersection ID: 15146	Main Street: DRESDEN_DR_EAST	Cross Street: WOODLAND_DR	Location: SW
ADA ID: 6265D373891D	Ramp Type: BlendTrans1	Initial Pass/Fail: Fail	Overall Compliance: No
		Severity Score: 8.75

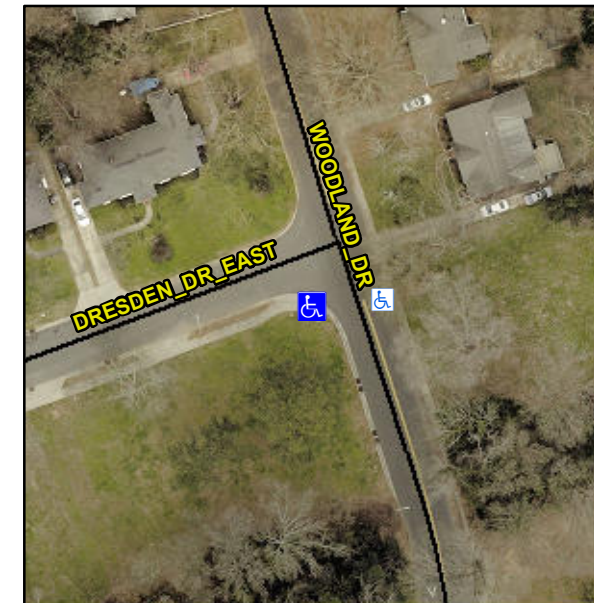
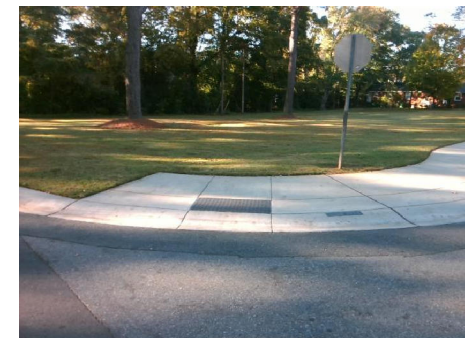
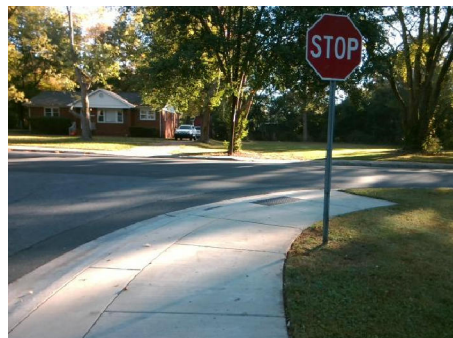
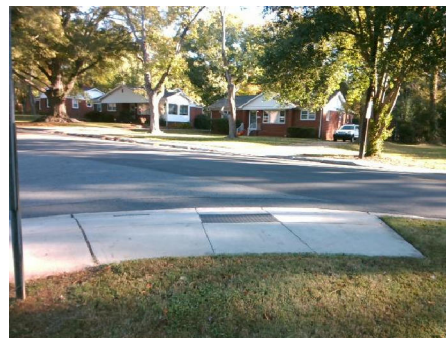
**NO LT SW**

**Not Found, R304.5.1**

Compliance	Description	Data	Compliance	Description	Data
N/A	Ramp Length (in)	85.0	Yes	BlendTrans Slope (%)	3.2
No	Ramp Width (in)	46.5	Yes	BlendTrans XSlope (%)	0.9
N/A	Flare Type LT	N/A	N/A	Flare Type RT	N/A
N/A	Flare Slope LT (%)	N/A	N/A	Flare Slope RT (%)	N/A
N/A	Flare Traversable LT?	N/A	N/A	Flare Traversable RT?	N/A
N/A	Landing Length (in)	N/A	N/A	DWS Provided?	N/A
N/A	Landing Width (in)	N/A	N/A	DWS Contrast?	N/A
N/A	Landing Slope (%)	N/A	N/A	DWS Length (in)	N/A
N/A	Landing X Slope (%)	N/A	N/A	DWS Full Width?	N/A
N/A	Landing Curb? (Y/N)	N/A	N/A	DWS Offset (in)	N/A
N/A	Shared Landing?	N/A			
N/A	Gutter Ponding?	N/A	N/A	Gutter Slope (%)	N/A
N/A	Gutter Lip Ht (in)	N/A	N/A	Gutter X Slope (%)	N/A
N/A	Painted X Walk1?	No	N/A	Painted X Walk2?	N/A
	X Walk 1 Direction	To E		X Walk 2 Direction	N/A
	X Walk 1 Width (in)	N/A		X Walk 2 Width (in)	N/A
	X Walk 1 Slope (%)	1.1		X Walk 2 Slope (%)	N/A
	X Walk 1 X Slope (%)	5.0		X Walk 2 X Slope (%)	N/A

N/A	Ramp inside XWalk1?	N/A	N/A	Ramp inside XWalk2?	N/A
	Road Slope (%)	5.0		Clear Space?	N/A
	Road X Slope (%)	1.1	N/A	Clear Space to XWalk (in)	N/A
N/A	Any Obstructions?	N/A	N/A	Storm Grate/Utility Hazard?	N/A
	Obstruction Type			Storm Grate/Utility Type	
		N/A			N/A
			Yes	Surface Condition? (G/P)	Good
			No	Curb Slope (%)	18.2

**Remove & Replace Curb Ramp With Two New Directional Ramps or Equivalent.**
