# Access Compliance Report

## Public Rights-of-Way

### (Curb Ramps)

Intersection ID: 16148	Main Street: OAK_LAKE_BV	Cross Street: YORKMONT_RD	Location: E
ADA ID: 626A47221F0E	Ramp Type: PerpDiag	Initial Pass/Fail: Fail	Overall Compliance: No
Severity Score: 50			
Codes/Mitigation Info/Possible Solution		Field Measurements/Component Compliance

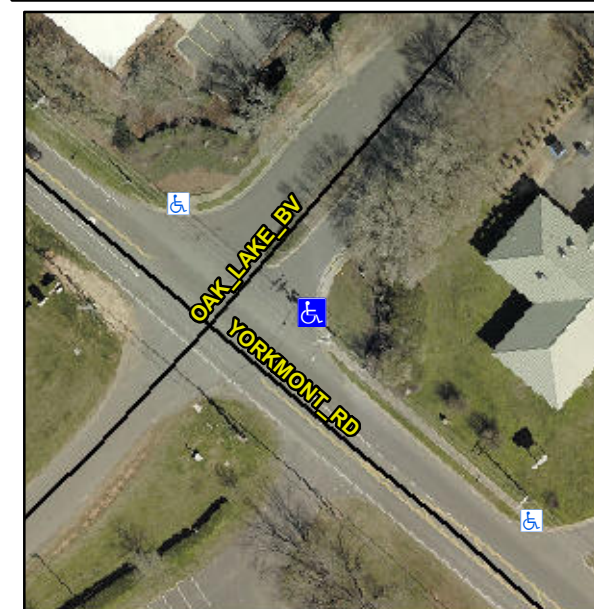
**Not Found, R304.2.2, R304.5.3**

Compliance	Description	Data	Compliance	Description	Data
N/A	Ramp Length (in)	51.0	No	Ramp Slope (%)	13.4
Yes	Ramp Width (in)	49.0	No	Ramp XSlope (%)	7.4
N/A	Flare Type LT	N/A	N/A	Flare Type RT	N/A
N/A	Flare Slope LT (%)	N/A	N/A	Flare Slope RT (%)	N/A
N/A	Flare Traversable LT?	N/A	N/A	Flare Traversable RT?	N/A
N/A	Landing Length (in)	N/A	N/A	DWS Provided?	N/A
N/A	Landing Width (in)	N/A	N/A	DWS Contrast?	N/A
N/A	Landing Slope (%)	N/A	N/A	DWS Length (in)	N/A
N/A	Landing X Slope (%)	N/A	N/A	DWS Full Width?	N/A
N/A	Landing Curb? (Y/N)	N/A	N/A	DWS Offset (in)	N/A
N/A	Shared Landing?	N/A			
N/A	Gutter Ponding?	N/A	N/A	Gutter Slope (%)	N/A
N/A	Gutter Lip Ht (in)	N/A	N/A	Gutter X Slope (%)	N/A
N/A	Painted X Walk1?	No	N/A	Painted X Walk2?	No
	X Walk 1 Direction	To NW		X Walk 2 Direction	To SW
N/A	X Walk 1 Width (in)	N/A	N/A	X Walk 2 Width (in)	N/A
	X Walk 1 Slope (%)	2.9		X Walk 2 Slope (%)	7.0
	X Walk 1 X Slope (%)	5.5		X Walk 2 X Slope (%)	0.7

N/A	Ramp inside XWalk1?	N/A	N/A	Ramp inside XWalk2?	N/A
	Road Slope (%)	3.6	N/A	Clear Space?	N/A
	Road X Slope (%)	7.1	N/A	Clear Space to XWalk (in)	N/A
N/A	Any Obstructions?	N/A	N/A	Storm Grate/Utility Hazard?	N/A
	Obstruction Type			Storm Grate/Utility Type	
		N/A			N/A
			Yes	Surface Condition? (G/P)	Good

**Remove & Replace Curb Ramp With Two New Directional Ramps or Equivalent.**
