Intersection ID: 11267	Main Street: DRUMMOND_AV	Cross Street: DUNCAN_AV	Location:	SE
ADA ID: 627D34D987EF	Ramp Type: Perp	Initial Pass/Fail: Fail	Overall Compliance: No	Severity Score: 30

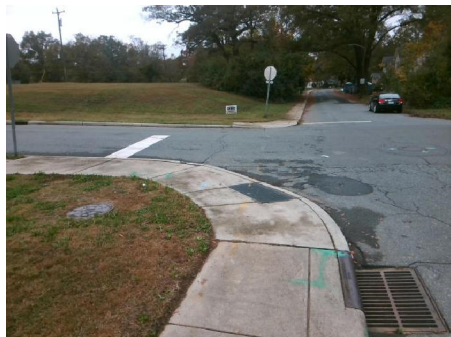
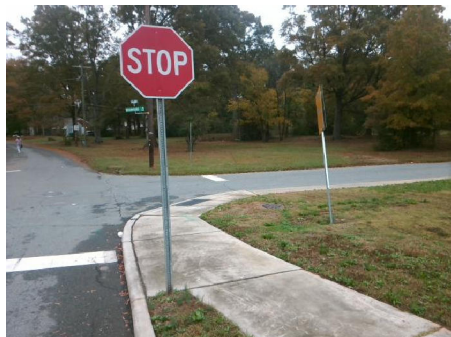
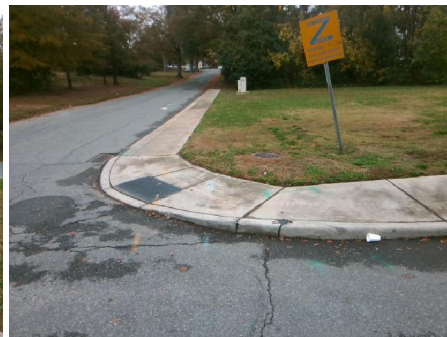
Codes/Mitigation Info/Possible Solution			Field Measurements/Component Compliance									
	Possible Solutions:		Compliance			Description			Data			
	Remove & Replace Entire Ramp.		N/A	Ramp Length (in)		62.5		No	Ramp Slope (%)		9.4	
			No	Ramp Width (in)		32.0		Yes	Ramp XSlope (%)		0.4	
			N/A	Flare Type LT		N/A		N/A	Flare Type RT		N/A	
			N/A	Flare Slope LT (%)		N/A		N/A	Flare Slope RT (%)		N/A	
			N/A	Flare Traversable LT?		N/A		N/A	Flare Traversable RT?		N/A	
			N/A	Landing Length (in)		N/A		N/A	DWS Provided?		N/A	
			N/A	Landing Width (in)		N/A		N/A	DWS Contrast?		N/A	
			N/A	Landing Slope (%)		N/A		N/A	DWS Length (in)		N/A	
			N/A	Landing X Slope (%)		N/A		N/A	DWS Full Width?		N/A	
Street 1 Name Stop Condition-Street 2 Street 2 Name Stop Condition-Street 1	Surveyor Notes:		N/A	Landing Curb? (Y/N)		N/A		N/A	DWS Offset (in)		N/A	
	N/A		N/A	Shared Landing?		N/A						
	PROW/ADA:		N/A	Gutter Ponding?		N/A		N/A	Gutter Slope (%)		N/A

Not Found, R304.5.1, R304.2.2		N/A	Gutter Lip Ht (in)		2.0		N/A	Gutter X Slope (%)		N/A	
			N/A	Painted X Walk1?		No		N/A	Painted X Walk2?		N/A	
				X Walk 1 Direction		To W			X Walk 2 Direction		N/A	
			N/A	X Walk 1 Width (in)		N/A		N/A	X Walk 2 Width (in)		N/A	
				X Walk 1 Slope (%)		3.2			X Walk 2 Slope (%)		N/A	
				X Walk 1 X Slope (%)		2.3			X Walk 2 X Slope (%)		N/A	
			N/A	Ramp inside XWalk1?		N/A		N/A	Ramp inside XWalk2?		N/A	
			Road Slope (%)		N/A		N/A	Clear Space?		N/A		
			Road X Slope (%)		N/A		N/A	Clear Space to XWalk (in)		N/A		
		N/A	Any Obstructions?		N/A		N/A	Storm Grate/Utility Hazard?		N/A		
			Obstruction Type					Storm Grate/Utility Type				
							N/A			N/A		
								Yes		Surface Condition? (G/P) Good		
Total Cost:		\$ 1850.00
