Access Compliance Report

Public Rights-of-Way

(Curb Ramps)

Intersection ID: 10027438	Main Street: GOODMAN_PARK_CT	Cross Street: N/A	Location: SE
ADA ID: 628211D746E4	Ramp Type: Perp	Initial Pass/Fail: Fail	Overall Compliance: No
Severity Score: 10			
Codes/Mitigation Info/Possible Solution		Field Measurements/Component Compliance

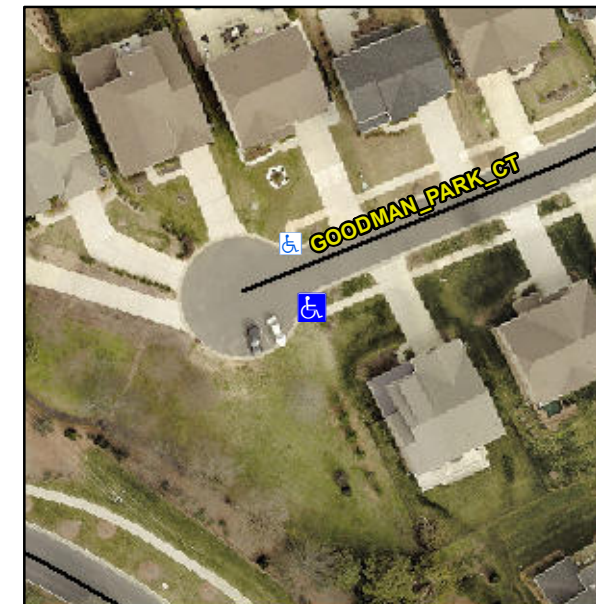
Not Found, R304.5.1, R304.5.3

Compliance	Description	Data	Compliance	Description	Data
N/A	Ramp Length (in)	93.0	Yes	Ramp Slope (%)	7.6
No	Ramp Width (in)	47.0	No	Ramp XSlope (%)	2.8
N/A	Flare Type LT	N/A	N/A	Flare Type RT	N/A
N/A	Flare Slope LT (%)	N/A	N/A	Flare Slope RT (%)	N/A
N/A	Flare Traversable LT?	N/A	N/A	Flare Traversable RT?	N/A
N/A	Landing Length (in)	N/A	N/A	DWS Provided?	N/A
N/A	Landing Width (in)	N/A	N/A	DWS Contrast?	N/A
N/A	Landing Slope (%)	N/A	N/A	DWS Length (in)	N/A
N/A	Landing X Slope (%)	N/A	N/A	DWS Full Width?	N/A
N/A	Landing Curb? (Y/N)	N/A	N/A	DWS Offset (in)	N/A
N/A	Shared Landing?	N/A			
N/A	Gutter Ponding?	N/A	N/A	Gutter Slope (%)	N/A
N/A	Gutter Lip Ht (in)	N/A	N/A	Gutter X Slope (%)	N/A
N/A	Painted X Walk1?	No	N/A	Painted X Walk2?	N/A
	X Walk 1 Direction	To NW		X Walk 2 Direction	N/A
N/A	X Walk 1 Width (in)	N/A	N/A	X Walk 2 Width (in)	N/A
	X Walk 1 Slope (%)	3.2		X Walk 2 Slope (%)	N/A
	X Walk 1 X Slope (%)	1.1		X Walk 2 X Slope (%)	N/A

N/A	Ramp inside XWalk1?	N/A	N/A	Ramp inside XWalk2?	N/A
	Road Slope (%)	N/A	N/A	Clear Space?	N/A
	Road X Slope (%)	N/A	N/A	Clear Space to XWalk (in)	N/A
N/A	Any Obstructions?	N/A	N/A	Storm Grate/Utility Hazard?	N/A
	Obstruction Type			Storm Grate/Utility Type	
		N/A			N/A
			Yes	Surface Condition? (G/P)	Good

Possible Solutions:

Remove & Replace Entire Ramp.
