# Access Compliance Report

## Public Rights-of-Way

### (Curb Ramps)

| Intersection ID: 9419 | Main Street: BUNGALOW_RD | Cross Street: N/A | Location: | E |

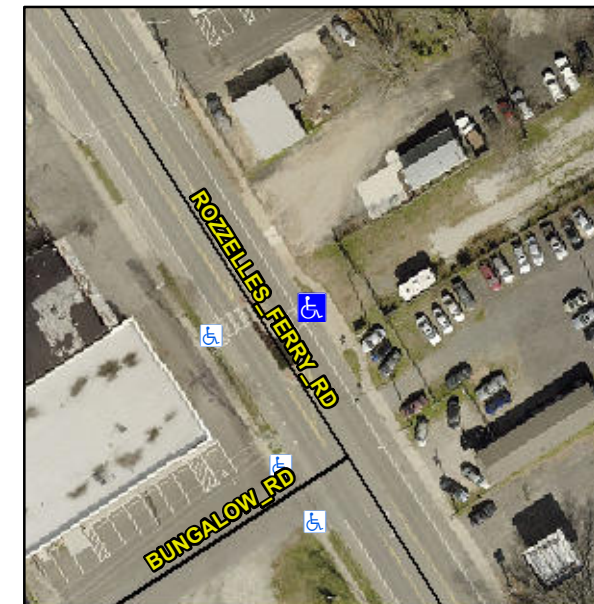
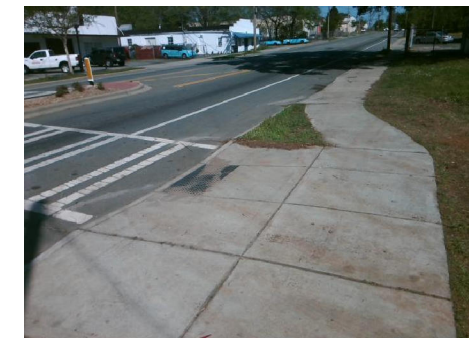
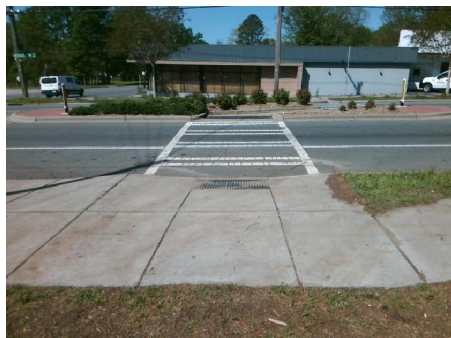
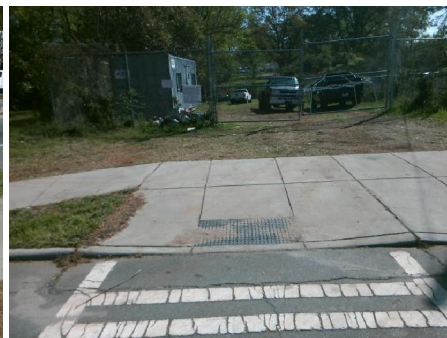
| ADA ID: 628AFA7016E5 | Ramp Type: Perp | Initial Pass/Fail: Pass | Overall Compliance: No | Severity Score: 0.25 |

**Not Found, R304.5.3**

| Compliance | Description | Data | Compliance | Description | Data |
|---|---|---|---|---|---|
| Yes | Ramp Width (in) | 48.0 | No | Ramp XSlope (%) | 2.9 |
| No | Landing X Slope (%) | 2.5 | Yes | DWS Full Width? | Yes |
| Yes | Gutter Lip Ht (in) | 0.0 | No | Gutter X Slope (%) | 3.3 |

**Remove & Replace Entire Ramp.  
Remove & Replace Gutter.**
