Access Compliance Report

Public Rights-of-Way

(Curb Ramps)

Intersection ID: 52289	Main Street: TROJAN_DR	Cross Street: DIXIE_RIVER_RD	Location: NW
ADA ID: 628E192B4057	Ramp Type: Perp	Initial Pass/Fail: Fail	Overall Compliance: No
		Severity Score: 25

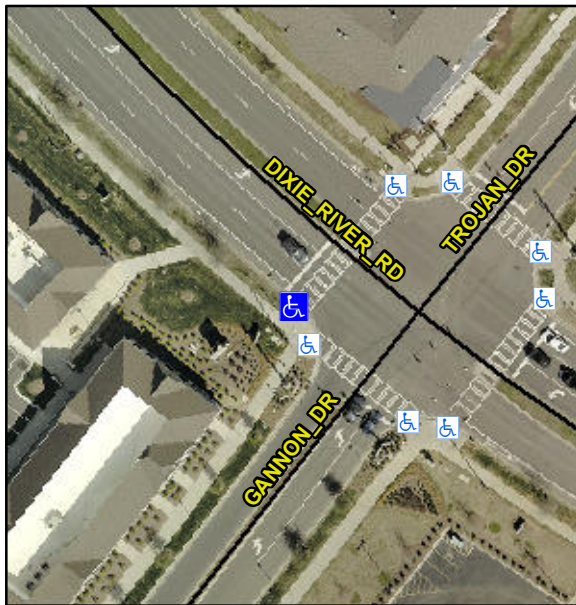
Not Found, R304.5.3

Compliance	Description	Data	Compliance	Description	Data
N/A	Ramp Length (in)	98.0	Yes	Ramp Slope (%)	6.9
Yes	Ramp Width (in)	48.0	No	Ramp XSlope (%)	9.6
N/A	Flare Type LT	N/A	N/A	Flare Type RT	N/A
N/A	Flare Slope LT (%)	N/A	N/A	Flare Slope RT (%)	N/A
N/A	Flare Traversable LT?	N/A	N/A	Flare Traversable RT?	N/A
N/A	Landing Length (in)	N/A	N/A	DWS Provided?	N/A
N/A	Landing Width (in)	N/A	N/A	DWS Contrast?	N/A
N/A	Landing Slope (%)	N/A	N/A	DWS Length (in)	N/A
N/A	Landing X Slope (%)	N/A	N/A	DWS Full Width?	N/A
N/A	Landing Curb? (Y/N)	N/A	N/A	DWS Offset (in)	N/A
N/A	Shared Landing?	N/A			
N/A	Gutter Ponding?	N/A	N/A	Gutter Slope (%)	N/A
N/A	Gutter Lip Ht (in)	N/A	N/A	Gutter X Slope (%)	N/A
N/A	Painted X Walk1?	Yes	N/A	Painted X Walk2?	N/A
	X Walk 1 Direction	To NE		X Walk 2 Direction	N/A
N/A	X Walk 1 Width (in)	112.0	N/A	X Walk 2 Width (in)	N/A
	X Walk 1 Slope (%)	0.9		X Walk 2 Slope (%)	N/A
	X Walk 1 X Slope (%)	3.8		X Walk 2 X Slope (%)	N/A

N/A	Ramp inside XWalk1?	Yes	N/A	Ramp inside XWalk2?	N/A
	Road Slope (%)	N/A	N/A	Clear Space?	N/A
	Road X Slope (%)	N/A	N/A	Clear Space to XWalk (in)	N/A
N/A	Any Obstructions?	N/A	N/A	Storm Grate/Utility Hazard?	N/A
	Obstruction Type			Storm Grate/Utility Type	
		N/A			N/A
			Yes	Surface Condition? (G/P)	Good

Remove & Replace Entire Ramp.
