Access Compliance Report

Public Rights-of-Way

(Curb Ramps)

Intersection ID: 13384	Main Street: S_MINT_ST	Cross Street: W_PARK_AV	Location: S
ADA ID: 62902F470BA2	Ramp Type: Directional1	Initial Pass/Fail: Fail	Overall Compliance: No
		Severity Score: 1.25

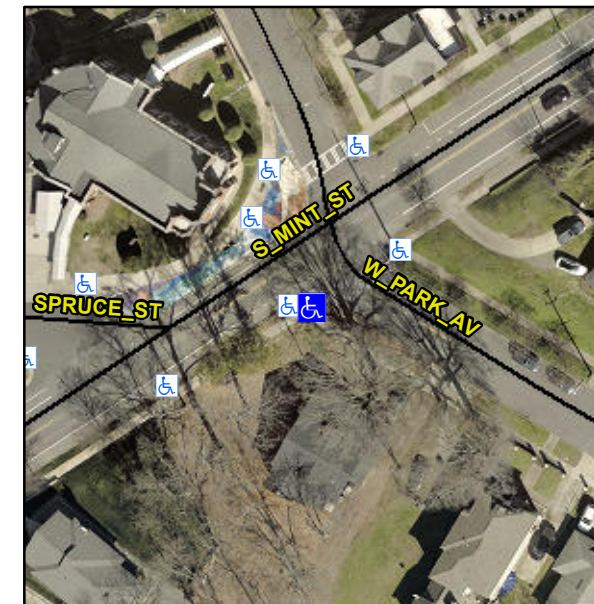
R304.5.3

Compliance	Description	Data	Compliance	Description	Data
N/A	Ramp Length (in)	114.0	N/A	Grade Break?	N/A
Yes	Ramp Width (in)	58.0	N/A	Grade Break Slope (%)	0.0
Yes	Ramp Slope (%)	5.2	N/A	Grade Break XSlope (%)	0.0
No	Ramp XSlope (%)	2.4			
N/A	Flare Type LT	N/A	N/A	Flare Type RT	N/A
N/A	Flare Slope LT (%)	N/A	N/A	Flare Slope RT (%)	0.0
N/A	Flare Traversable LT?	N/A	N/A	Flare Traversable RT?	N/A
N/A	Landing Length (in)	0.0	N/A	DWS Provided?	N/A
N/A	Landing Width (in)	0.0	N/A	DWS Contrast?	N/A
N/A	Landing Slope (%)	0.0	N/A	DWS Length (in)	N/A
N/A	Landing X Slope (%)	0.0	N/A	DWS Full Width?	N/A
N/A	Landing Curb? (Y/N)	N/A	N/A	DWS Offset LT (in)	N/A
N/A	Shared Landing?	N/A	N/A	DWS Offset RT (in)	N/A
N/A	Gutter Ponding?	0.0	N/A	Gutter Slope (%)	N/A
N/A	Gutter Lip Ht (in)	0.0	N/A	Gutter X Slope (%)	N/A
N/A	Painted X Walk1?	No		Road Slope (%)	7.3
	X Walk 1 Direction	To NE		Road X Slope (%)	0.7
	X Walk 1 Width (in)	N/A		Clear Space?	N/A

X Walk 1 Slope (%)	7.3	N/A	Clear Space to XWalk (in)	N/A
	X Walk 1 X Slope (%)	0.7	N/A	Storm Grate/Utility Hazard?	N/A
N/A	Ramp inside XWalk1?	N/A		Storm Grate/Utility Type	
N/A	Any Obstructions?	N/A			N/A
	Obstruction Type		Yes	Surface Condition? (G/P)	Good
			N/A	Curb Slope (%)	1.0

Remove & Replace Entire Ramp.
