Access Compliance Report

Public Rights-of-Way

(Curb Ramps)

| Intersection ID: 10021247 | Main Street: BIRNEN_DR | Cross Street: N/A | Location: NW |

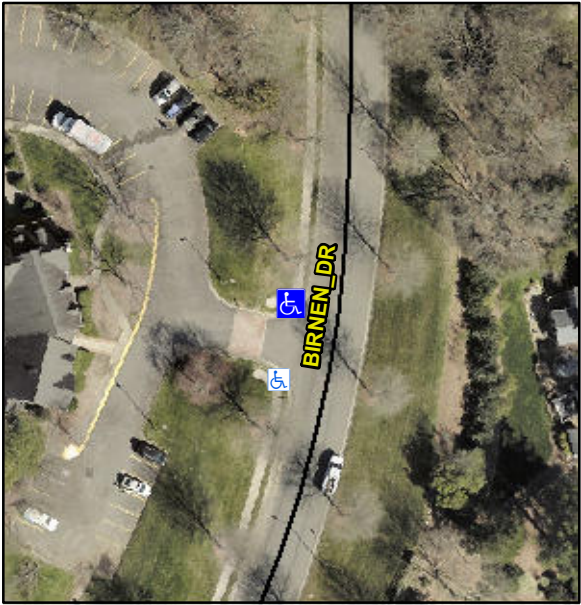
| ADA ID: 62A01865D8CC | Ramp Type: PerpDiag | Initial Pass/Fail: Fail | Overall Compliance: No |
| Severity Score: 37.5 | | | |

| | Remove & Replace Curb Ramp With Two New Directional Ramps or Equivalent. | | N/A | Ramp Length (in) | 61.0 | No | Ramp Slope (%) | 9.1 |
| <p>Surveyor Notes:</p> <p>N/A</p> <p>PROW/ADA:</p> <p>Not Found, R304.2.2, R304.5.3</p> | | | Yes | Ramp Width (in) | 51.0 | No | Ramp XSlope (%) | 13.1 |
